Upper Looking Glass River Watershed Management Plan

January 16, 2018

**Shiawassee Conservation
District**

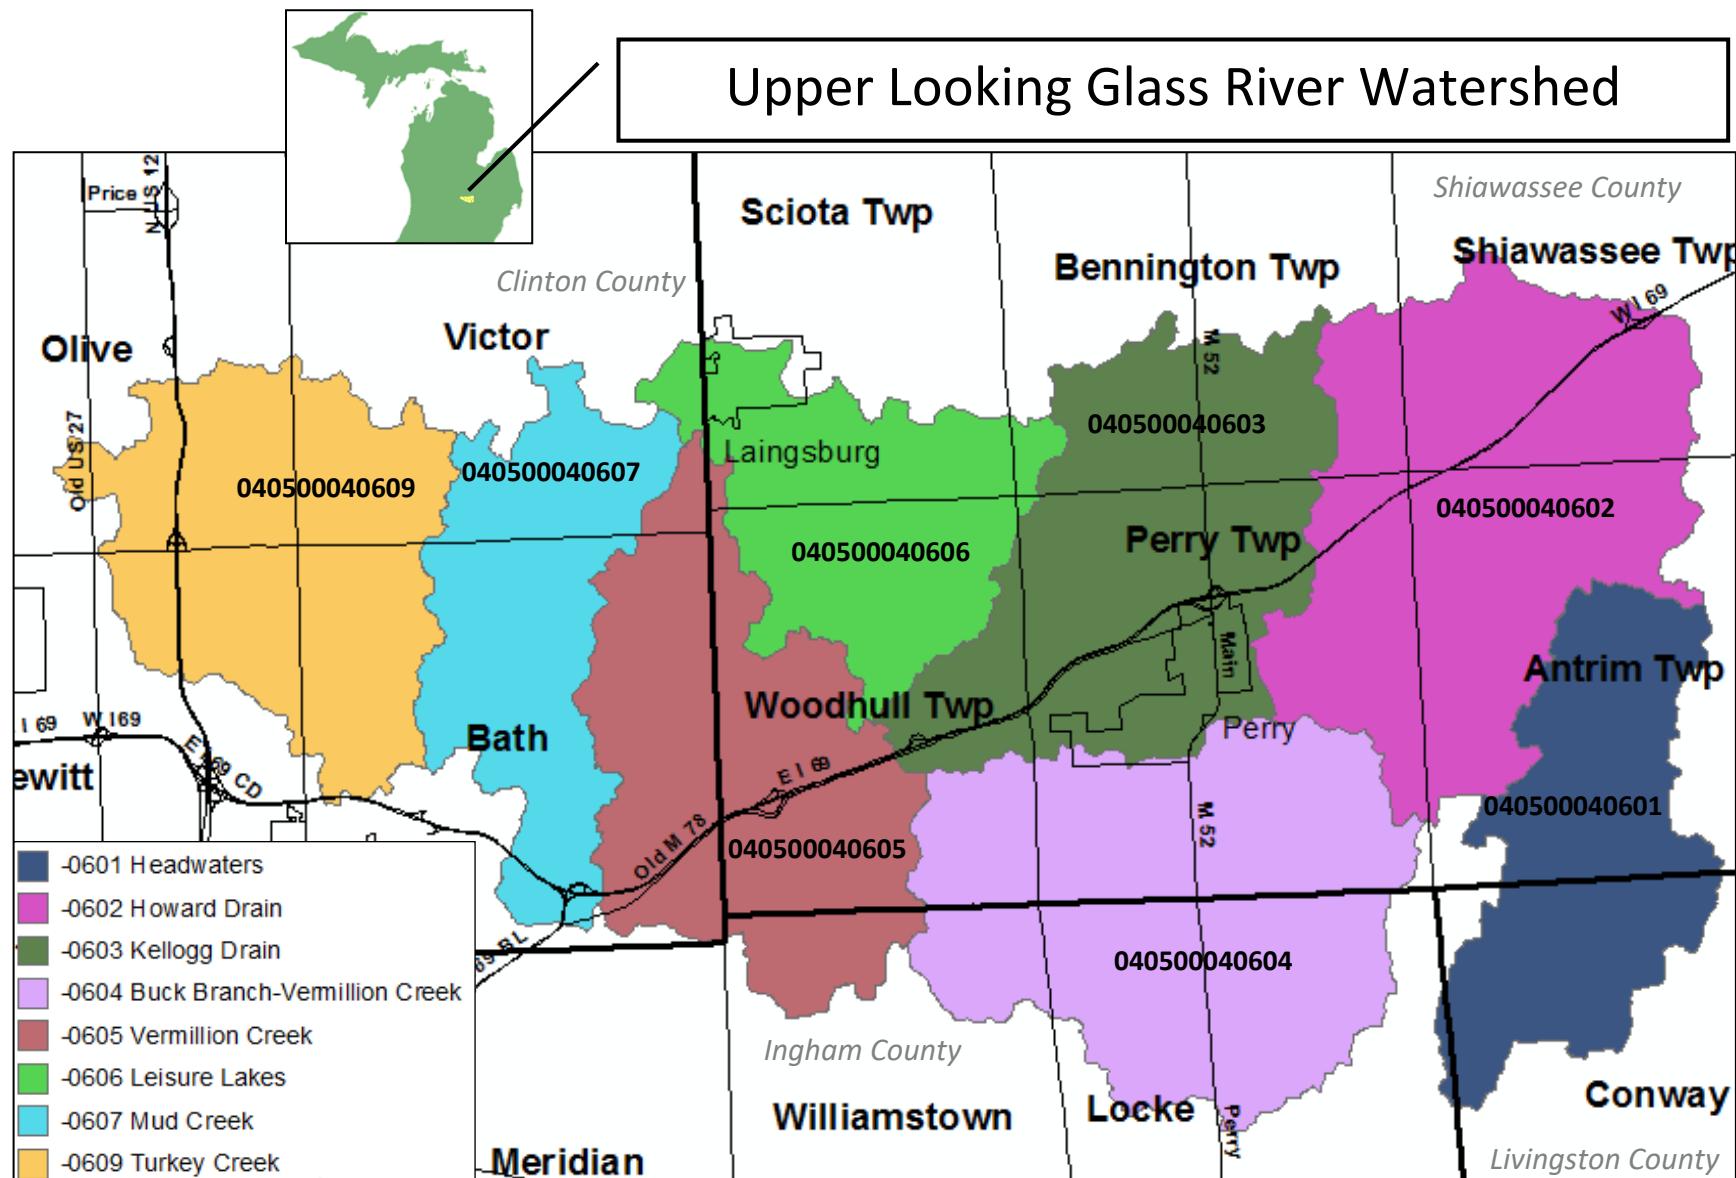
Figure 1.1 Upper Looking Glass River Watershed.

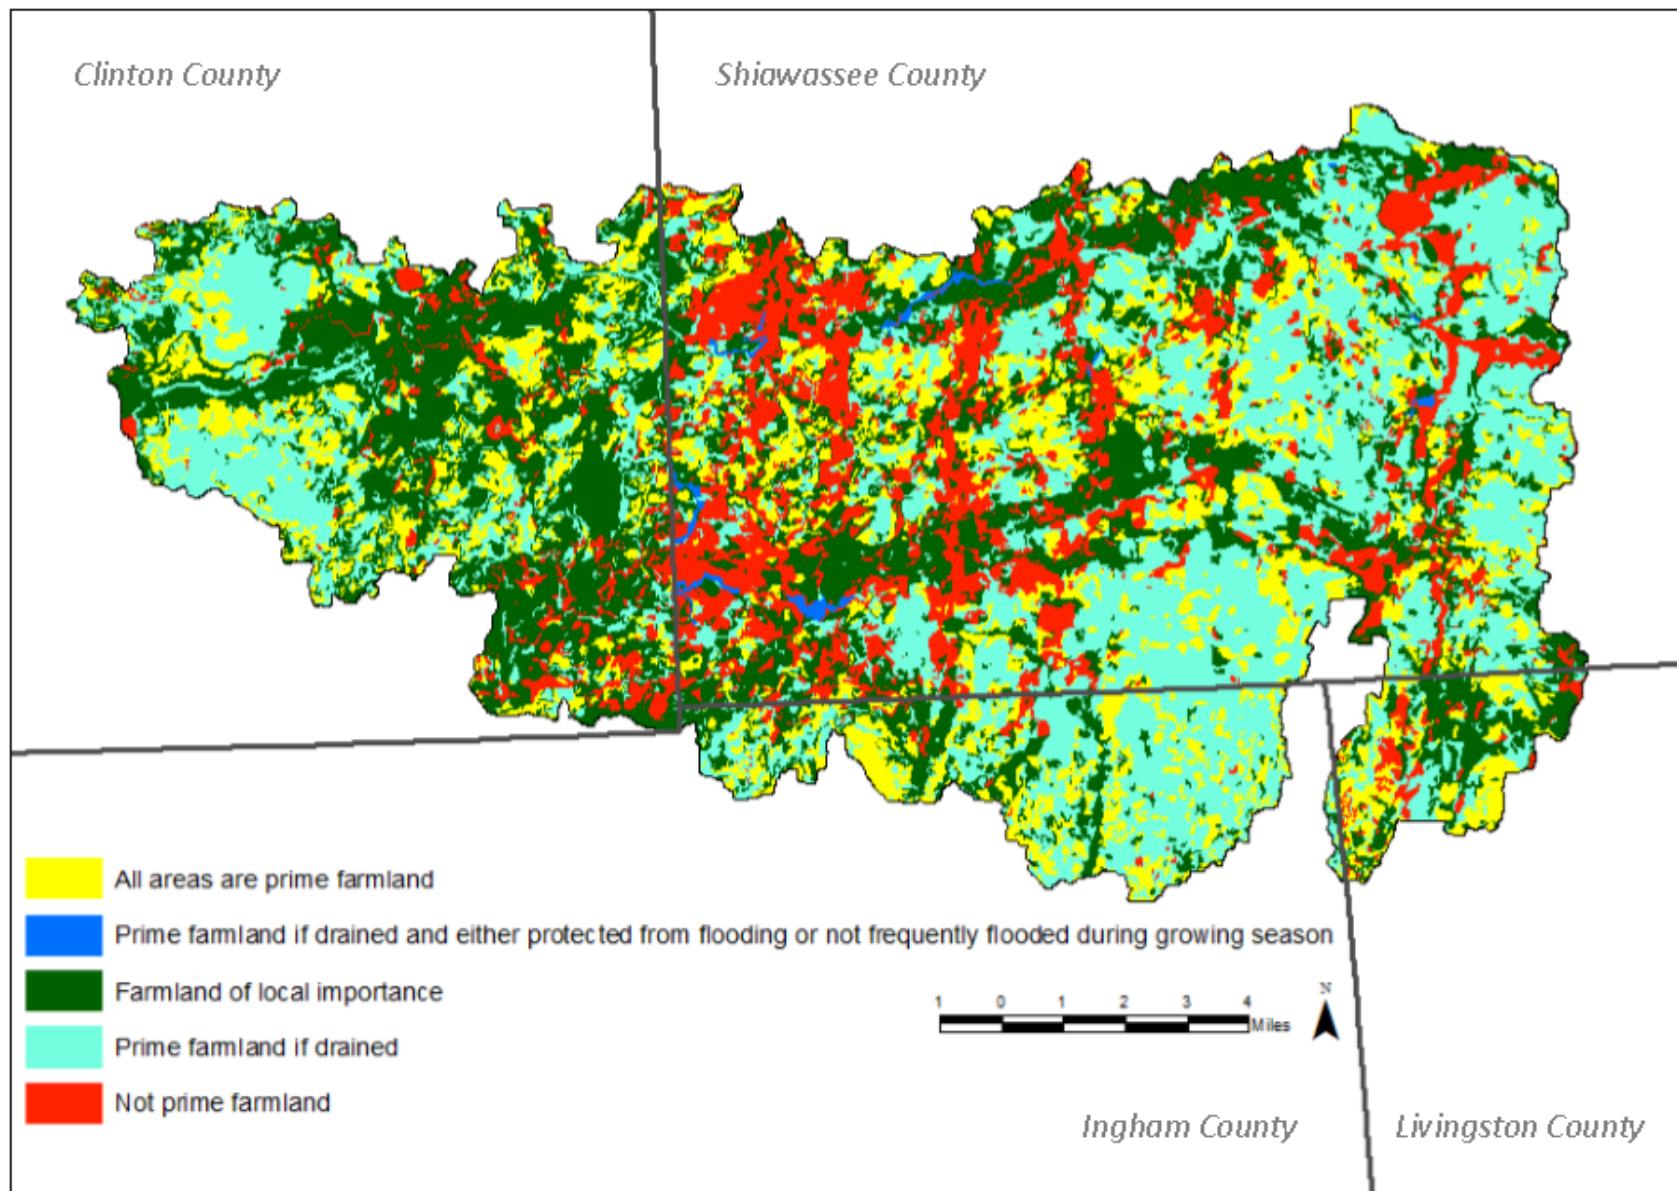
Figure 1.2 Prime Farmland in the Upper Looking Glass River Watershed.

A depiction of prime and unique farmland can be found in Figure 1.2.

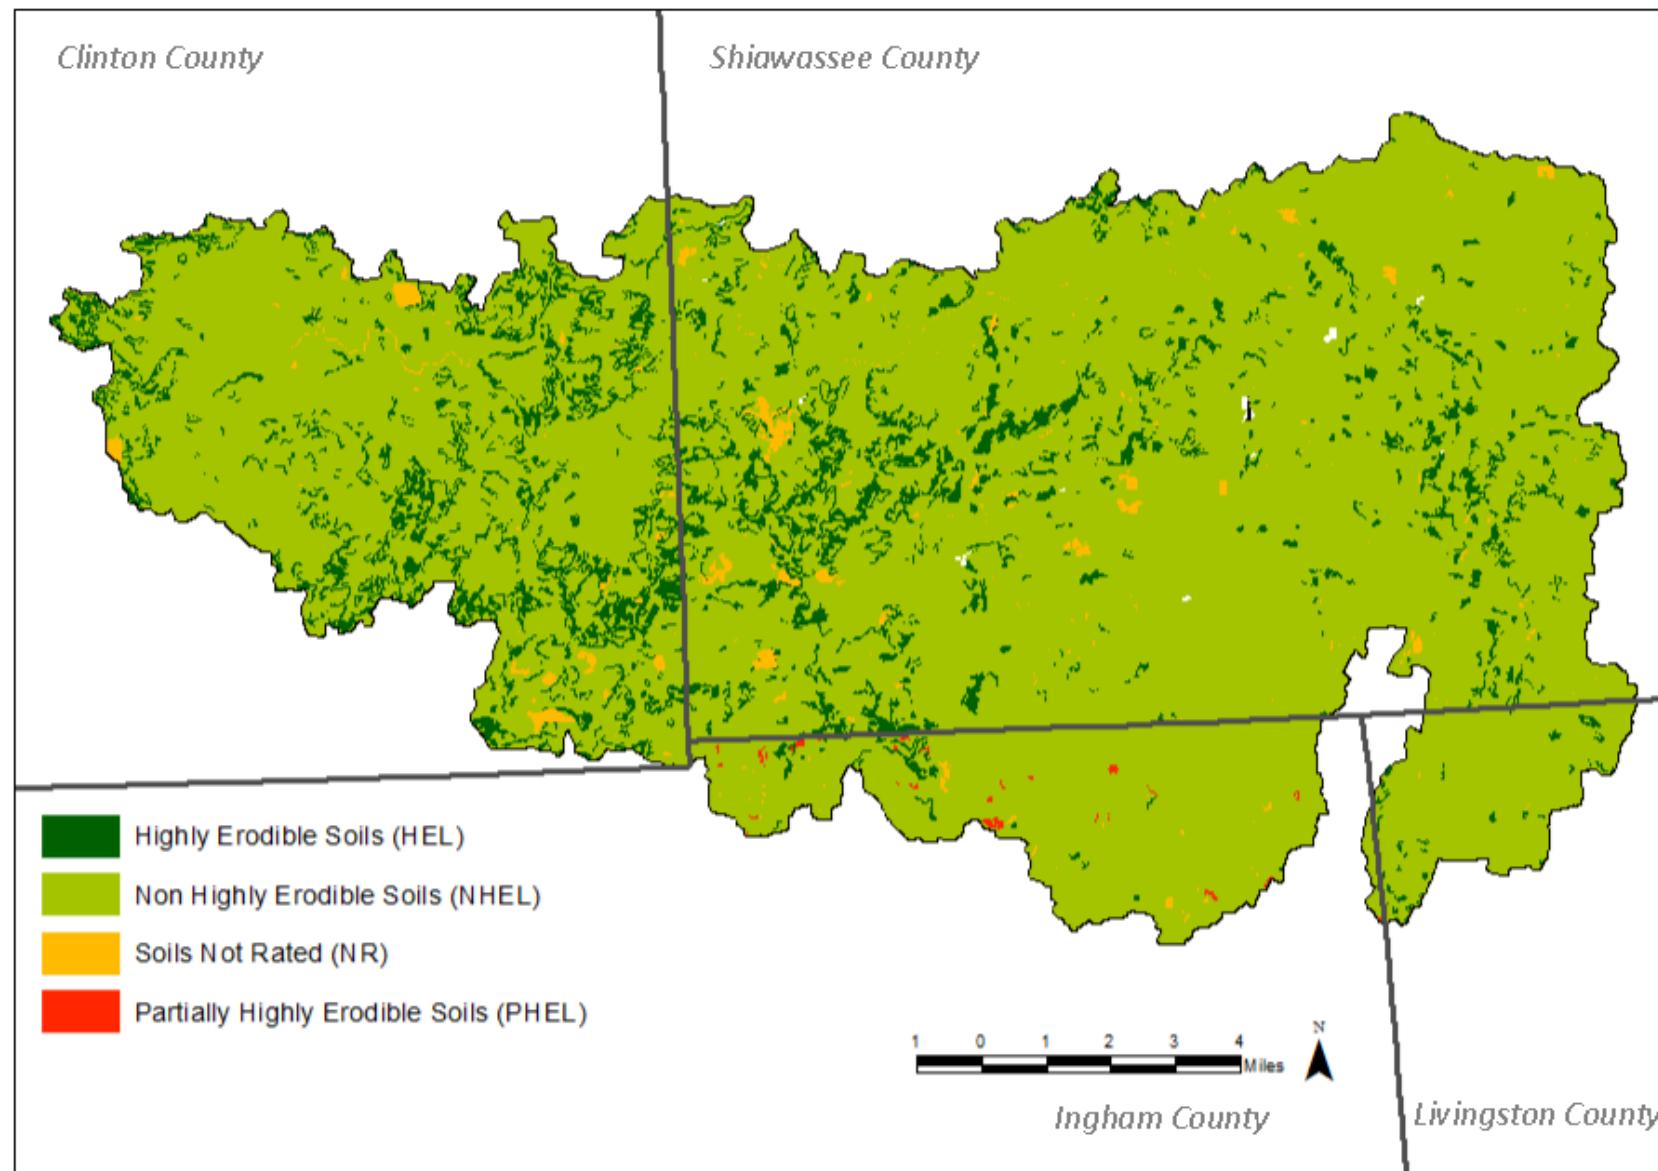
Figure 1.3 Highly Erodible Soils in the Upper Looking Glass River Watershed.

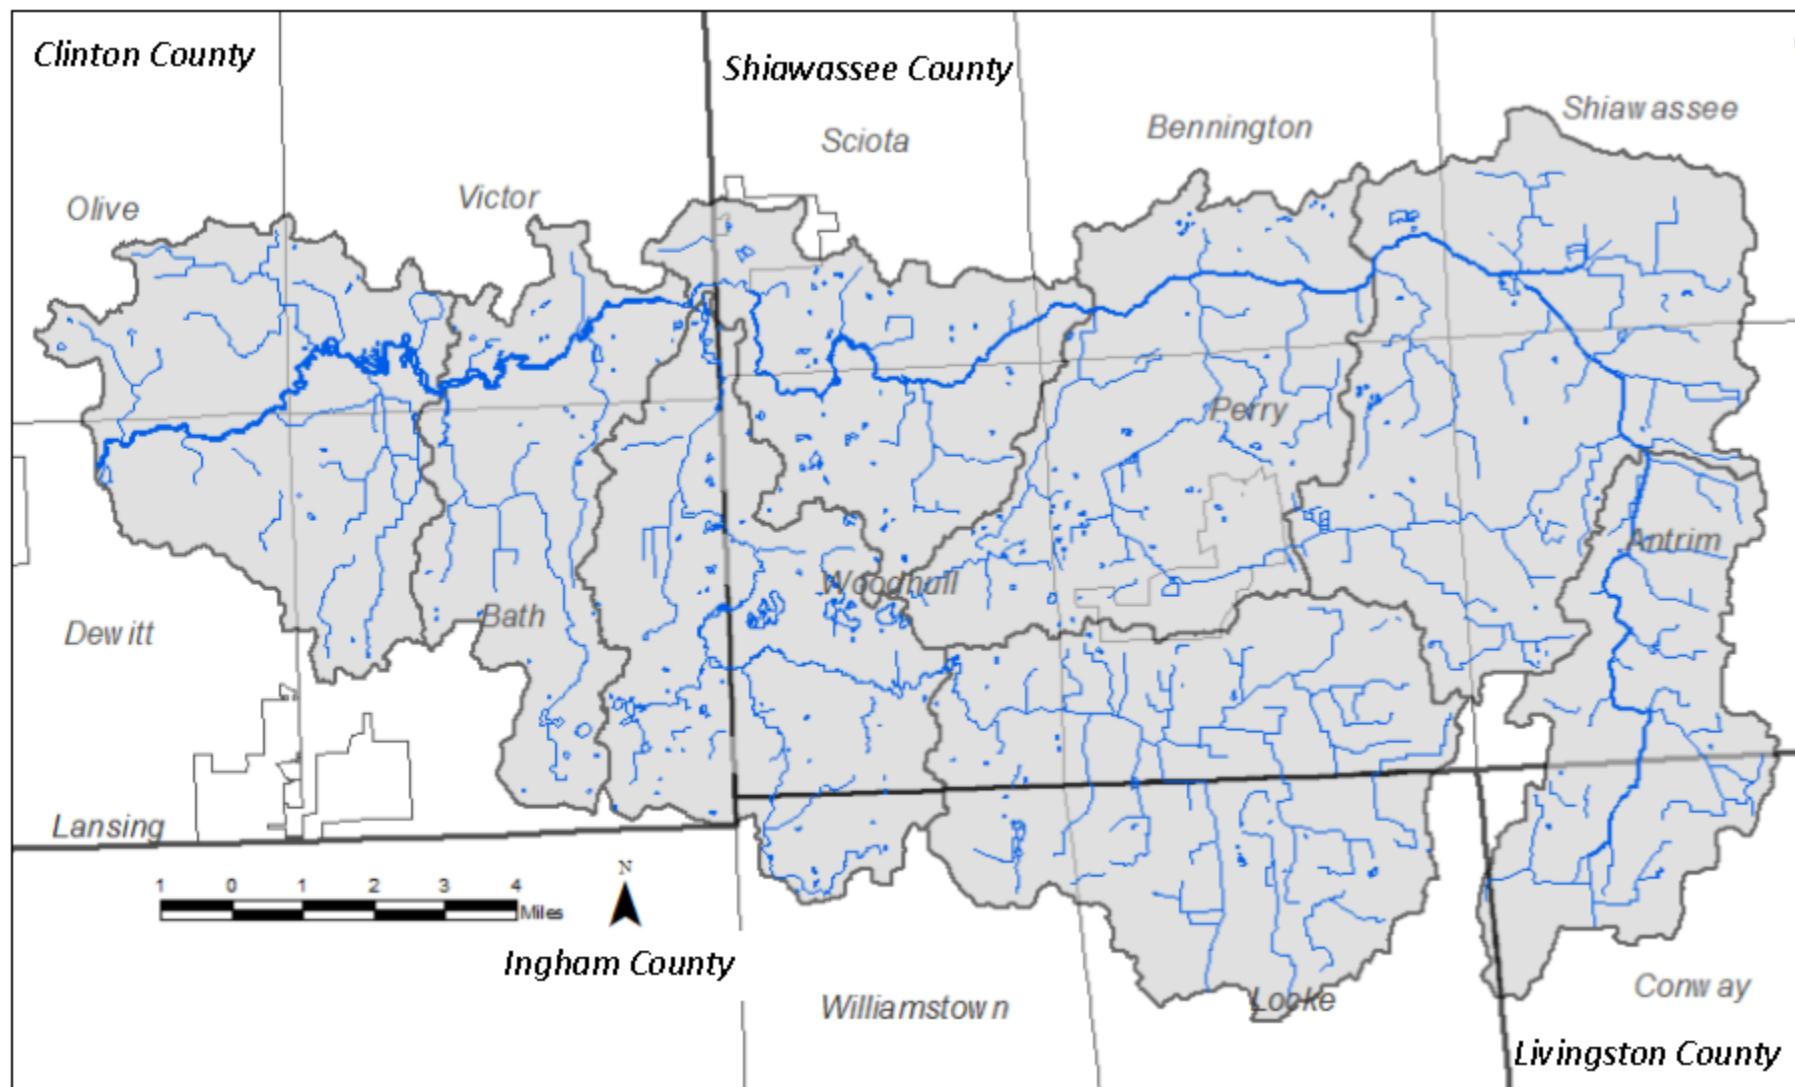
Figure 1.4 Surface water in the Upper Looking Glass River Watershed.

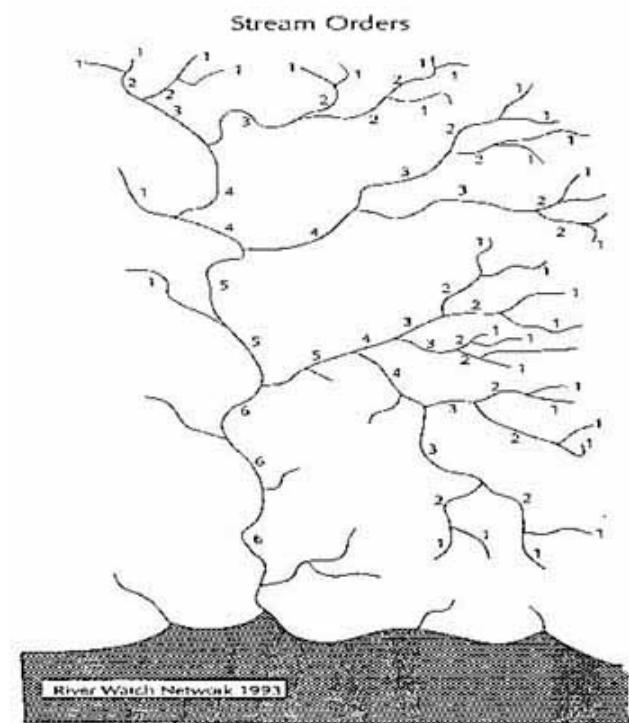
Figure 1.5.A representation of a river network with stream order marked.

The Looking Glass River falls approximately 210 feet in elevation and travels for 65 miles to where it empties into the Grand River. The Upper Looking Glass River Watershed contains large tracts of wetland and forested floodplain. However, much of the river and stream morphology have been altered from its natural design. Channels are commonly straightened and/or dredged to improve drainage from nearby low-lying farm fields and housing. The alteration of the river's natural meander creates some negative impacts in the watershed. Figure 1.5 depict stream order in a typical stream system.

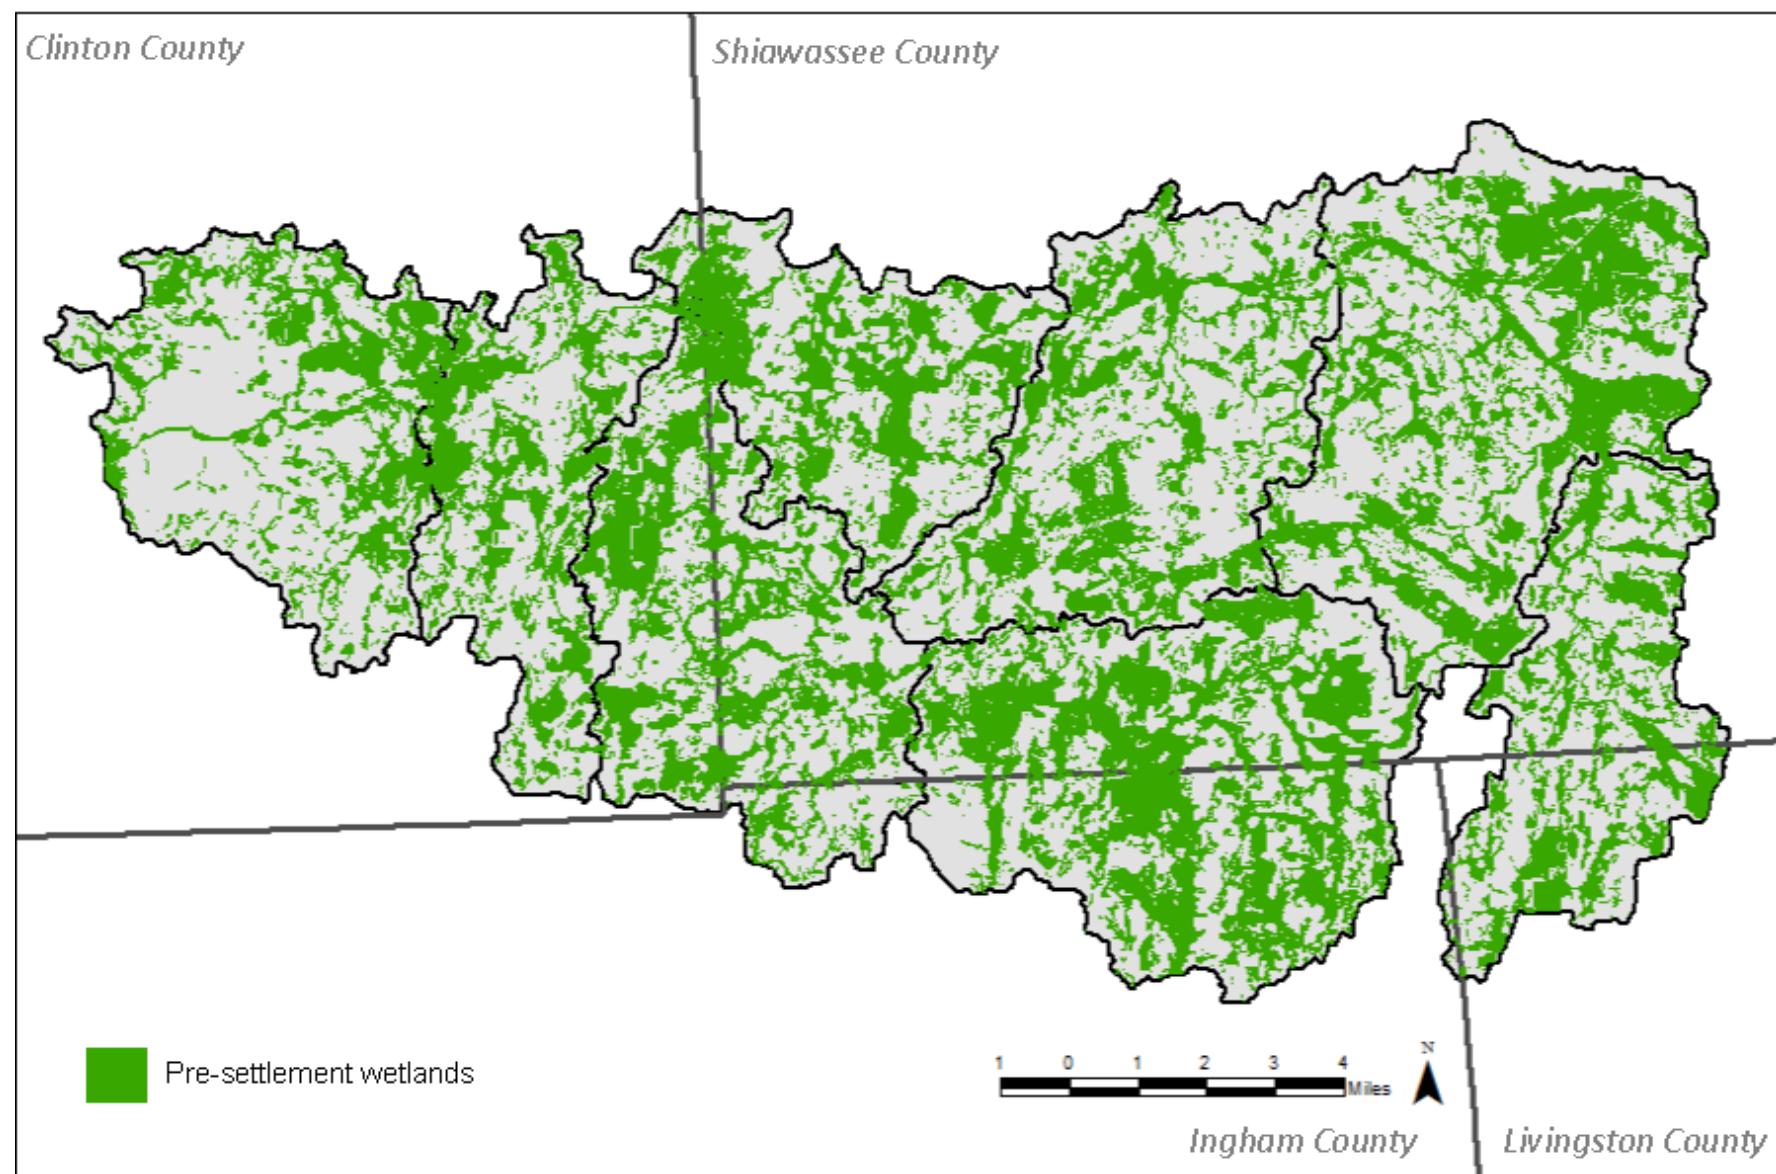
Figure 1.6 Pre-settlement wetlands in the Upper Looking Glass River Watershed (Source: MDEQ 2015).

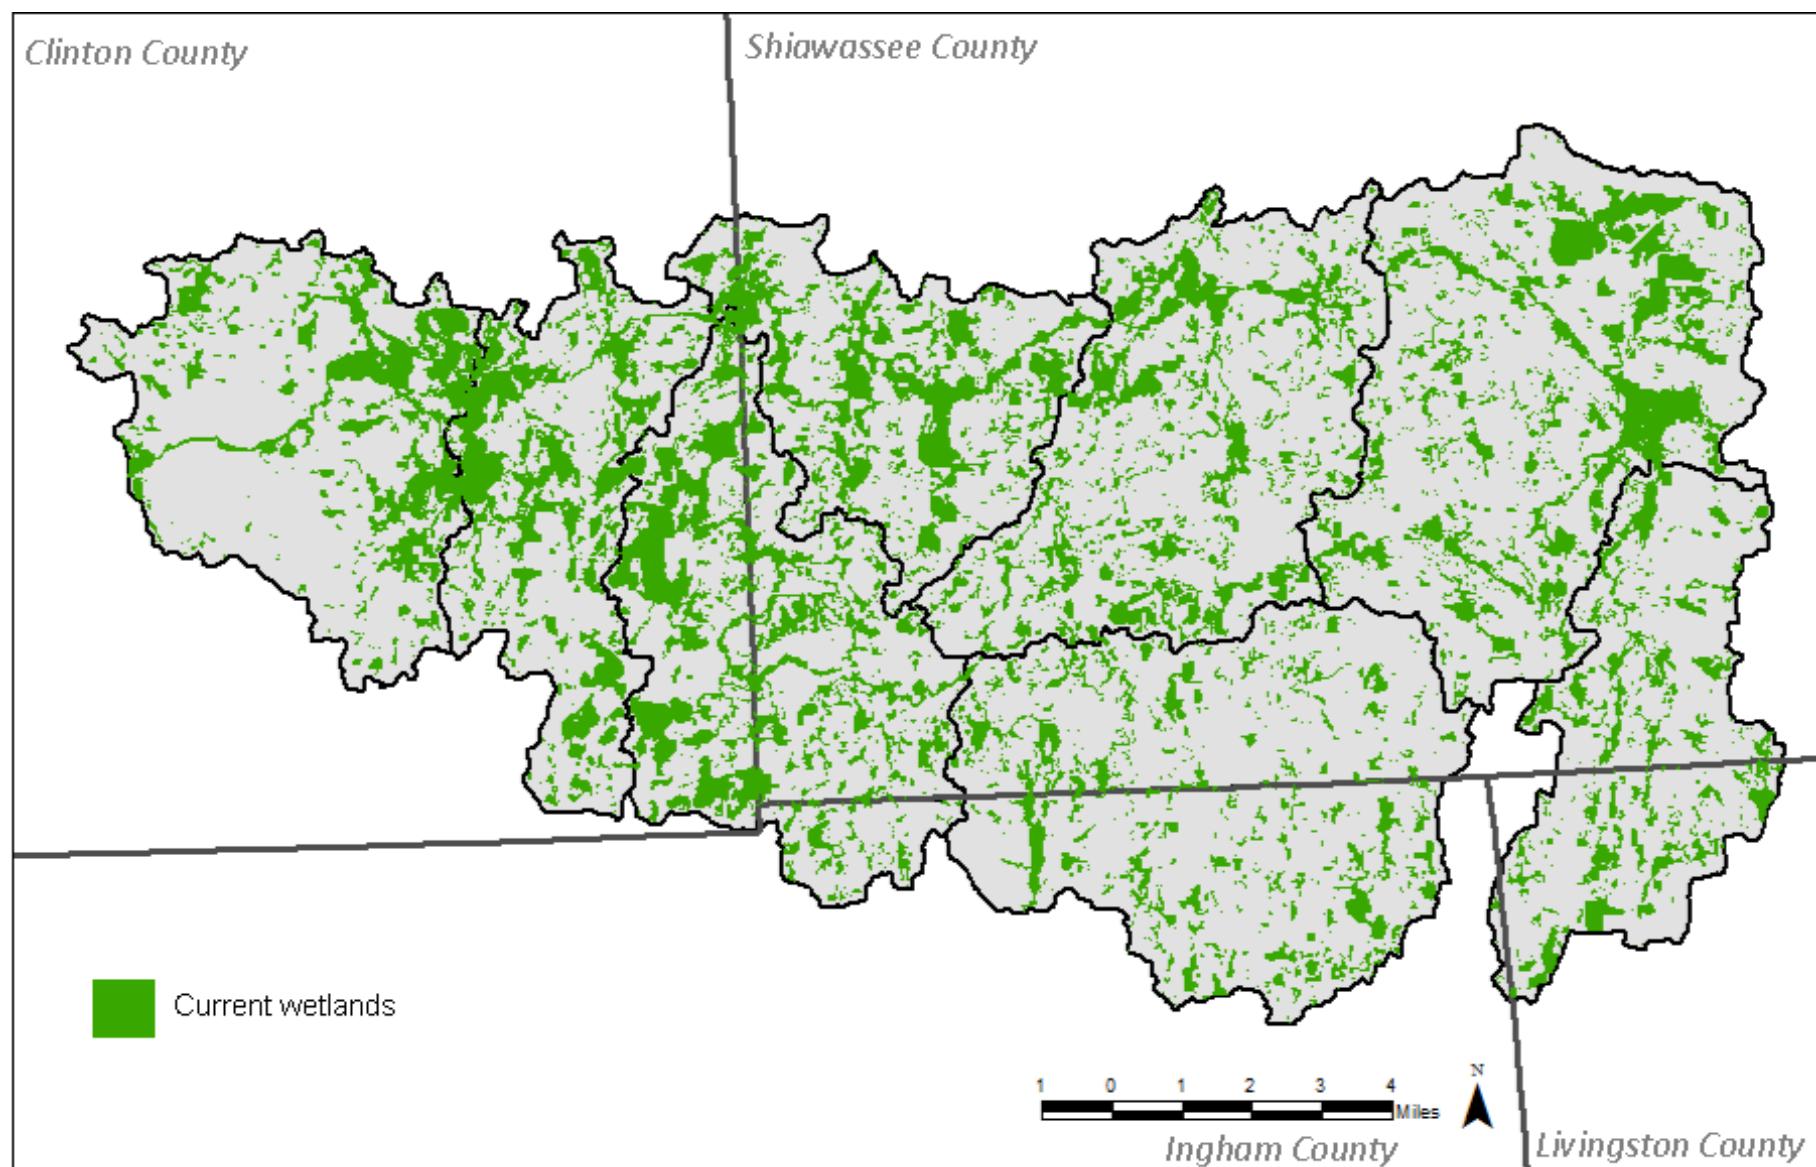
Figure 1.7 Current wetlands in the Upper Looking Glass River Watershed (Source: MDEQ 2015).

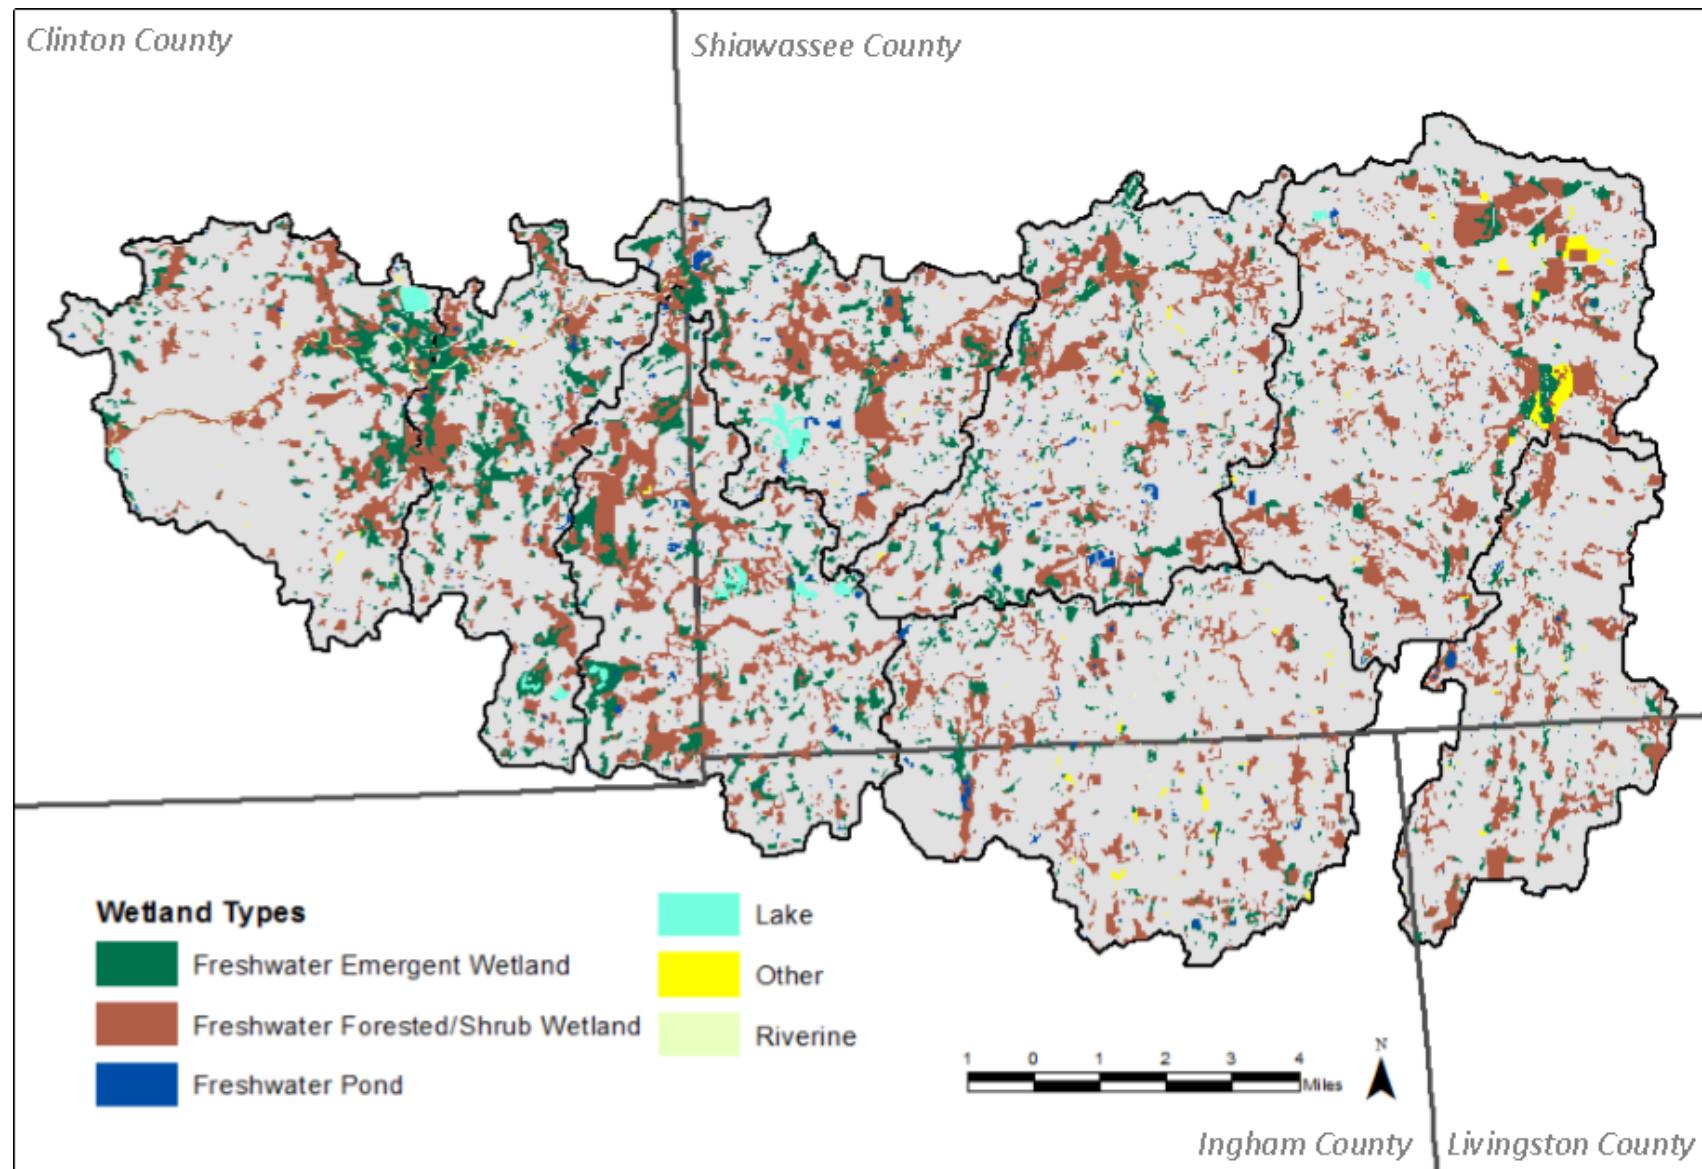
Figure 1.8 Wetland types in the Upper Looking Glass River Watershed (Source: US Fish and Wildlife Service 2017).

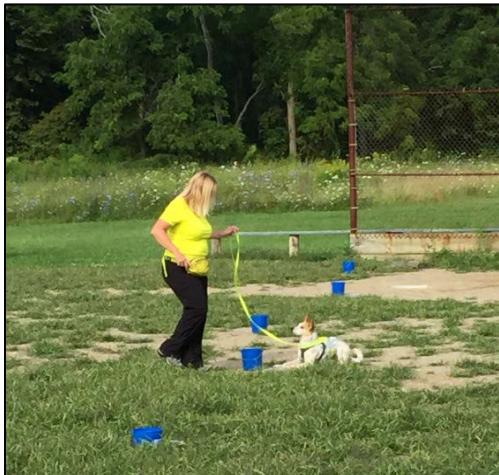
Figure 3.1 ECS canine Crush with Aryn Hervel alerting to the scent of human waste in this bucket taken from a ULG stream during the August 2015 survey.

Five sites were chosen for field investigation from the eight sites that were positively alerted to during the bucket analysis. Crush alerted at four of the five upstream investigation sites for bucket site #21, all four upstream sites for bucket site #18, one upstream site of bucket site #12, and two upstream sites for bucket site #6. Crush alerted at bucket site #7 in the field but not in either of the duplicate bucket samples. She did not alert at one of the upstream sites for bucket site #21, one upstream site for bucket site #6, and only one upstream bucket from site #23. Figure 3.1 shows the canine Crush with Aryn Hervel during the day 2 investigation.

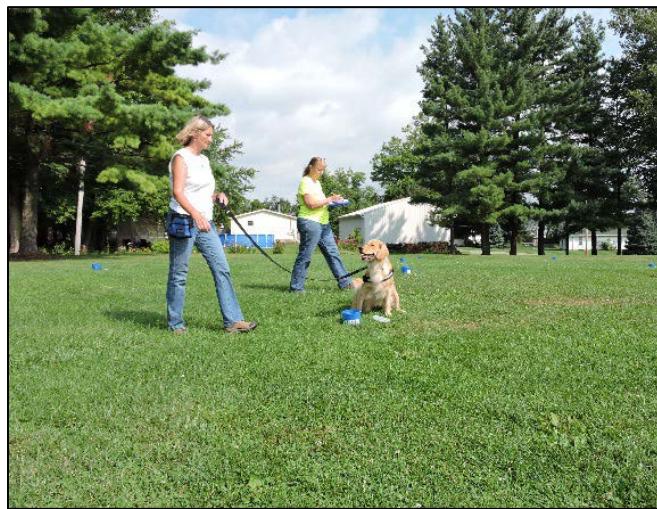
Figure 3.2 ECS canine Kenna with handler Laura Symonds and ECS president Karen Reynolds, alerting to human waste from a sample taken from a ULG stream during the August 2015 survey.

Three sites were chose from the 14 positive bucket sample responses for field investigation. Kenna alerted at one of the two upstream sites for bucket sample #30 and the only upstream site for sample #32. She did not alert at one upstream site for sample #30 and the only upstream site for sample #33. Additionally, Kenna did not alert at site #4 confirming Crush's response from Day 1. Figure 3.2 show the canine Kenna with handler Laura Symonds and ECS president Karen Reynolds during the day 2 investigation. Table 3.1 and Figure 3.3 provide a summary of the results. Figure 3.4 shows comparisons of *E. coli* measured from water samples taken during canine investigation. See Appendix 9 for full report.

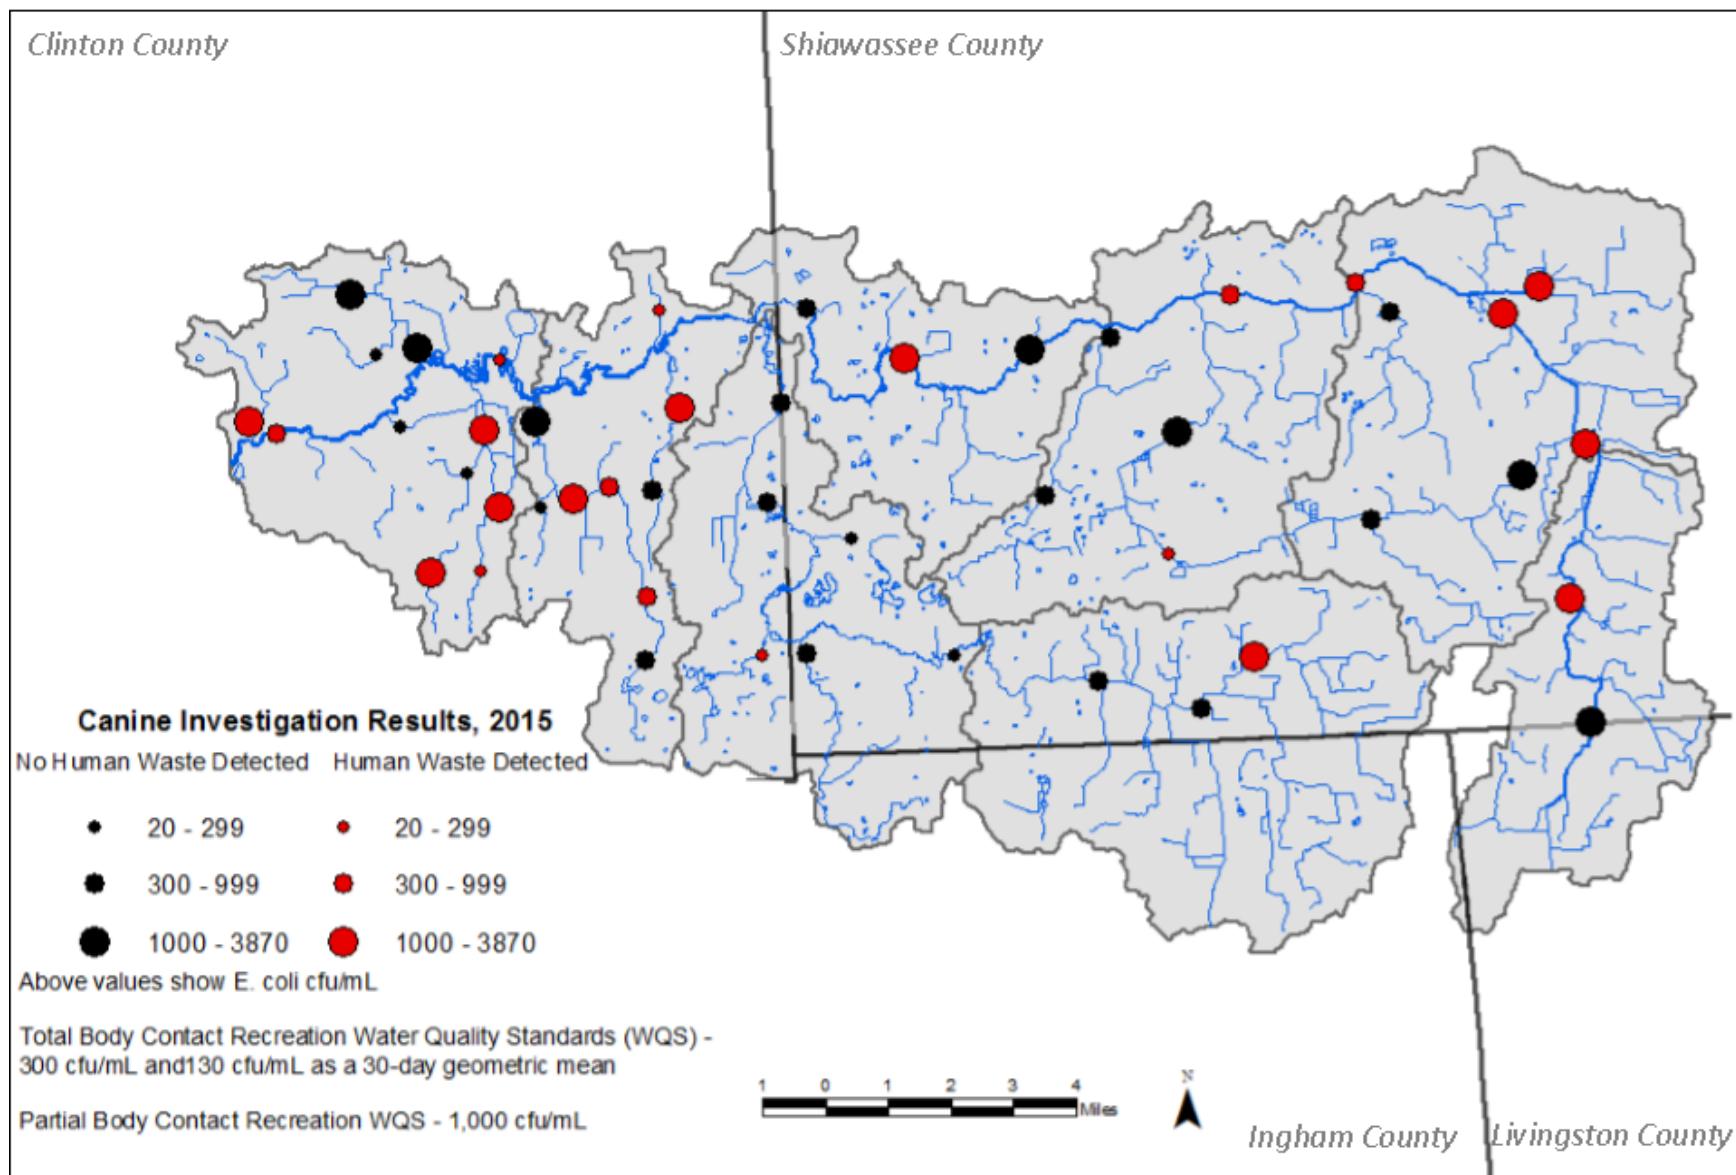
Figure 3.3 Spatial results from the canine scent survey conducted in 2015 in the Upper Looking Glass River Watershed. Values listed are E. coli colony forming units detected in water by laboratory analysis.

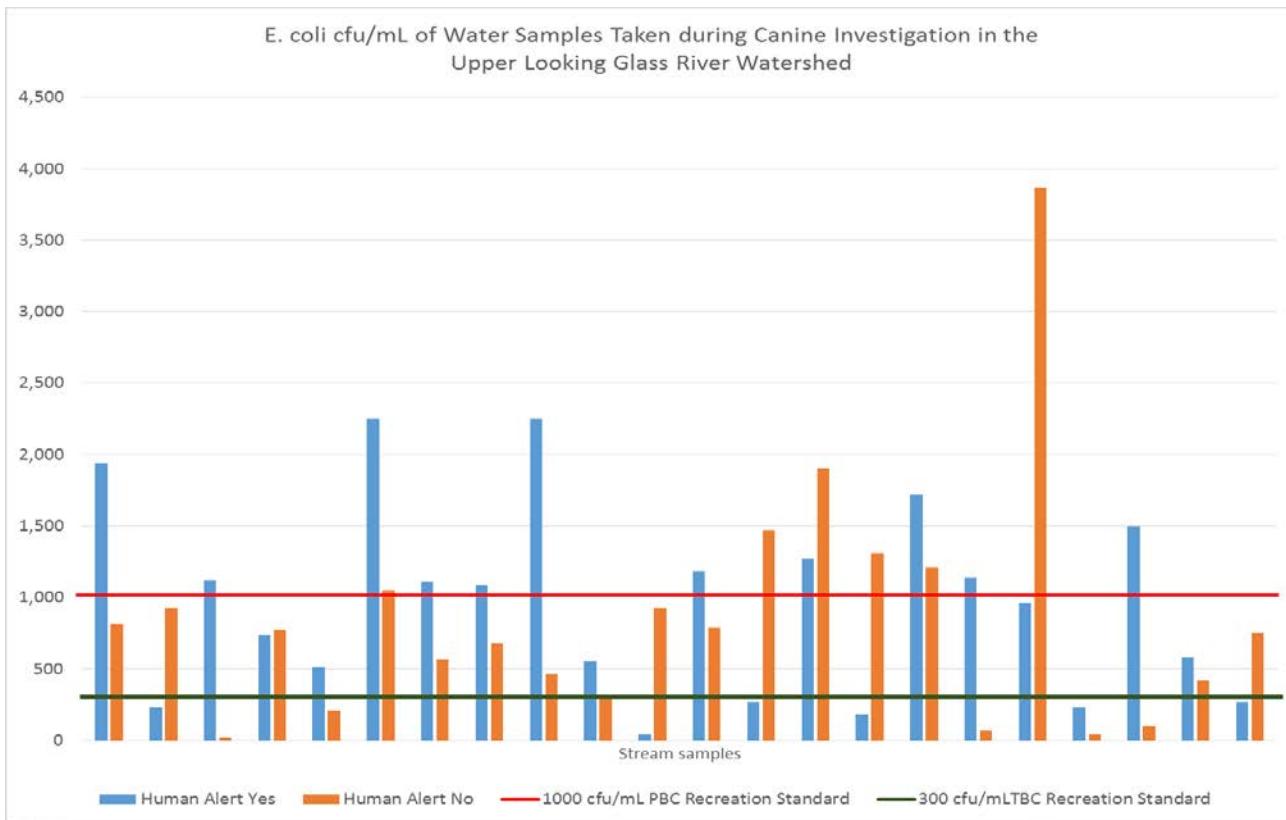
Figure 3.4 Comparison of *E. coli* (cfu/mL) levels to recreational WQS from water samples taken during Canine Investigation for the Upper Looking Glass River Watershed in 2015.

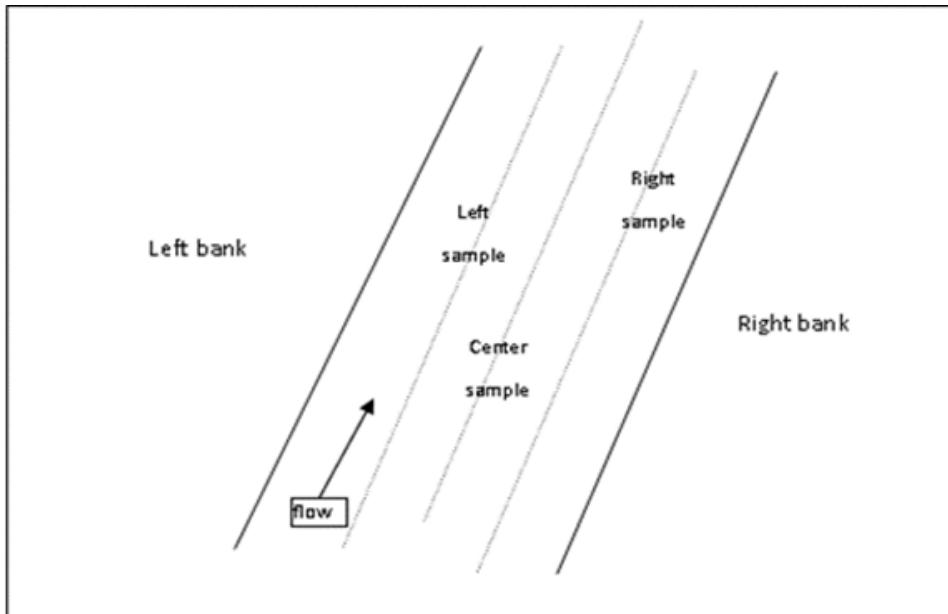
*Figure 3.5 Sampling scheme for *E. coli* samples taken on a river or stream*
(Source: MDEQ)

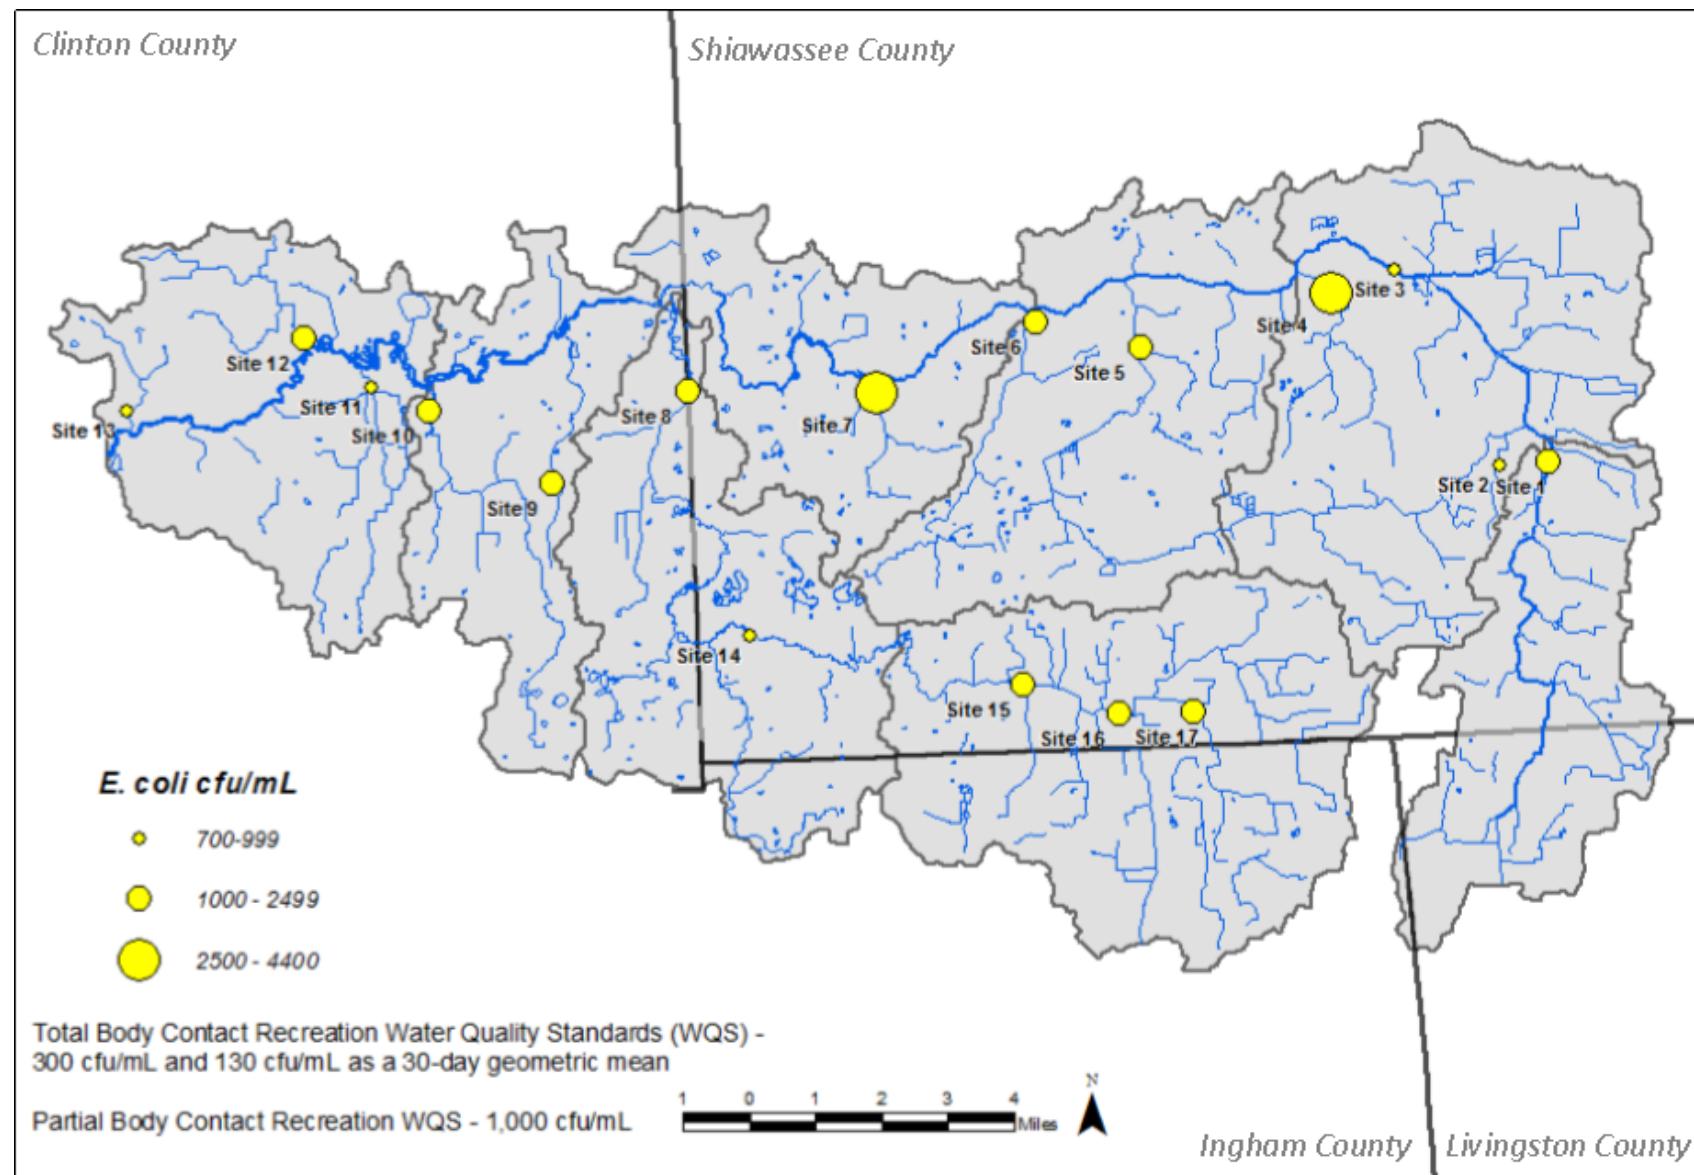
Figure 3.7 Spatial results from the 6-week *E. coli* investigation conducted in 2016 in the Upper Looking Glass River Watershed.

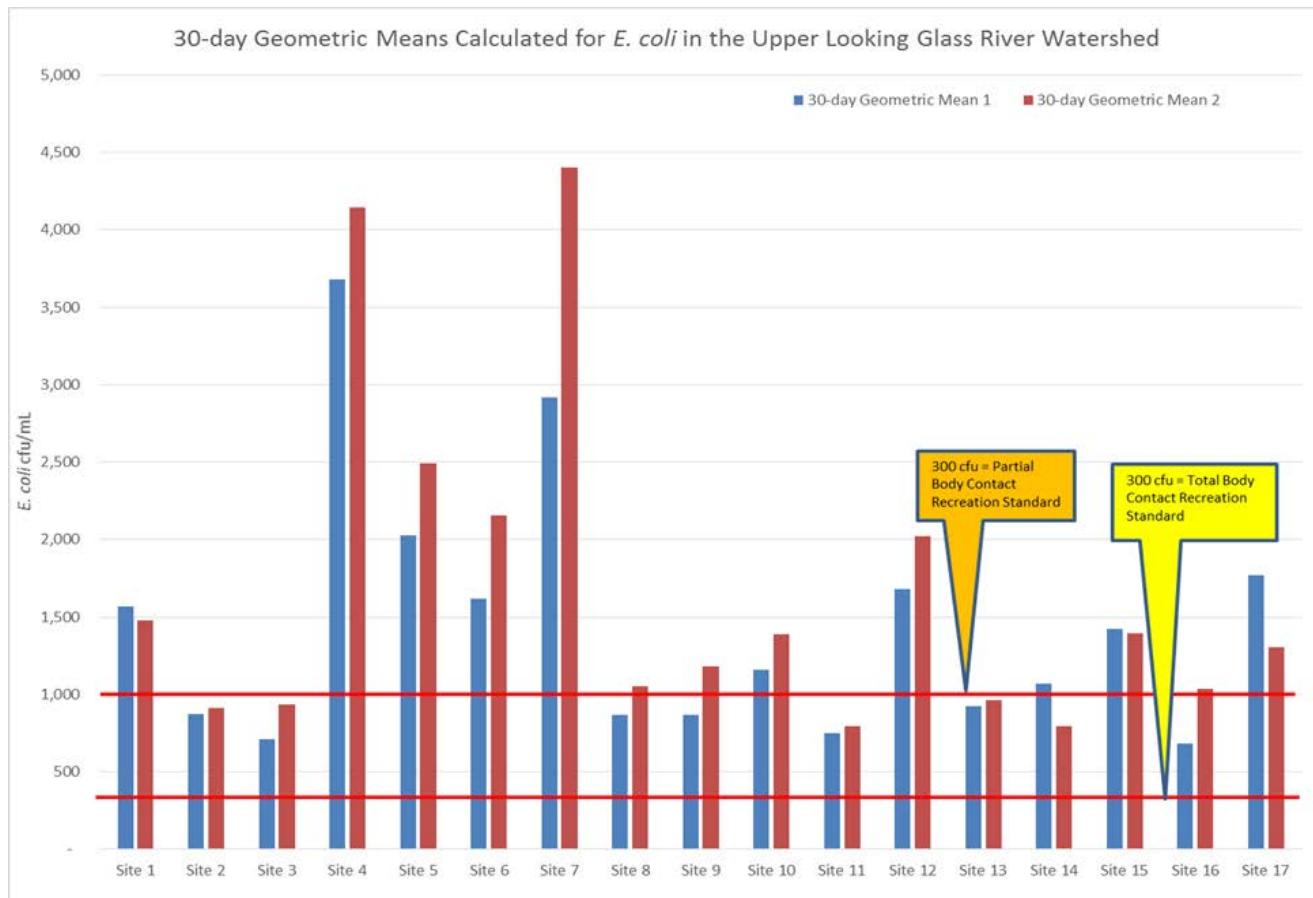
Figure 3.7 Comparison of the *E. coli* results (cfu/mL) from 6-week water analysis for the Upper Looking Glass River Watershed in 2016.
