Upper Looking Glass River Watershed Management Plan

January 16, 2018

**Shiawassee Conservation
District**

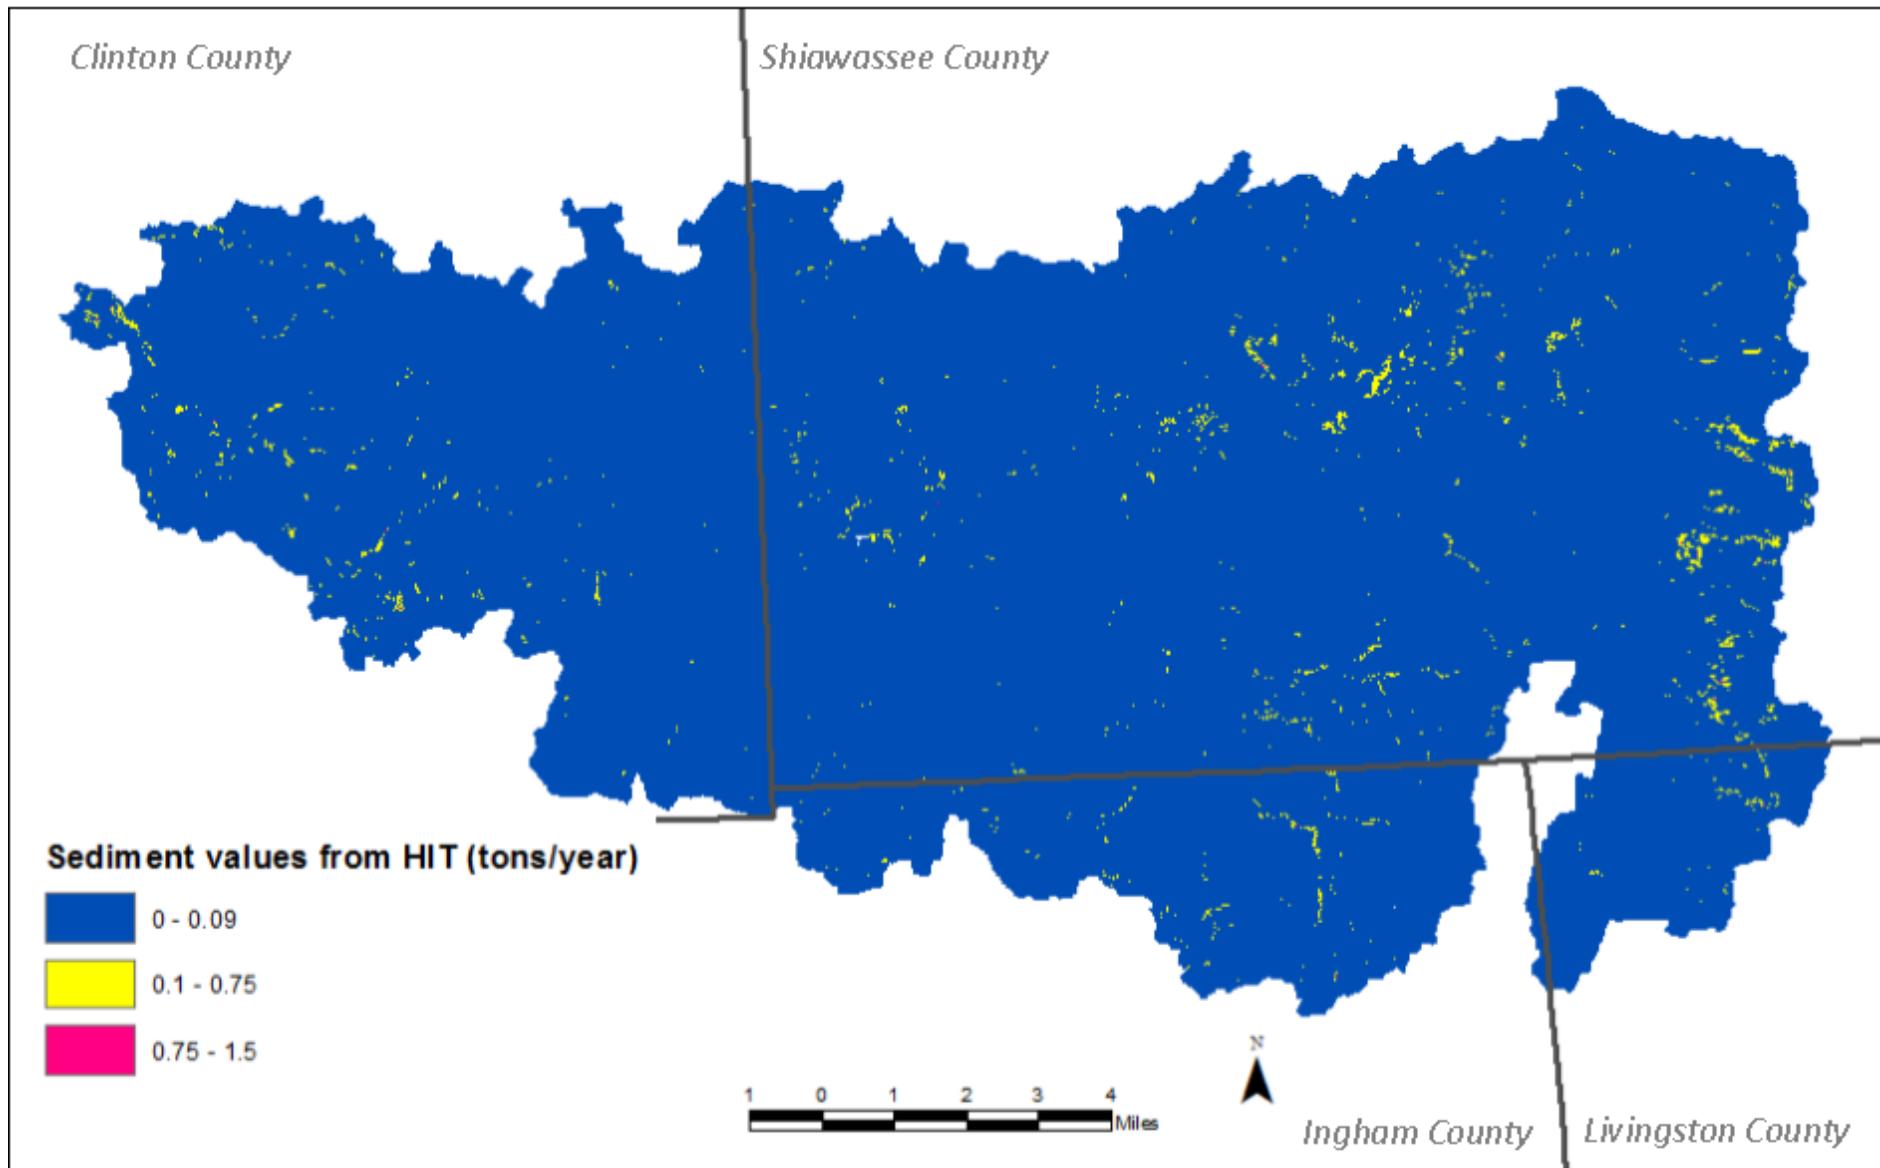
Figure 3.8 Estimated sediment values of agricultural soils lost to erosion as modeled by the High Impact Targeting (HIT) tool for the Upper Looking Glass River Watershed.

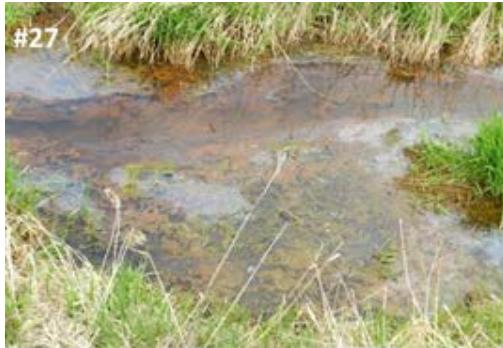
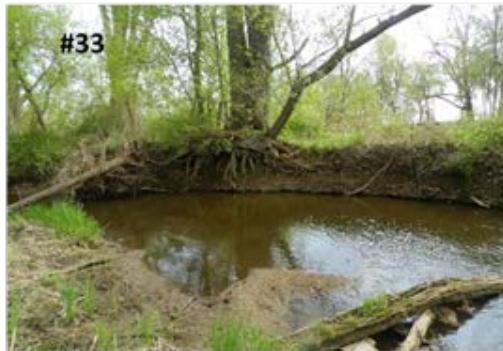
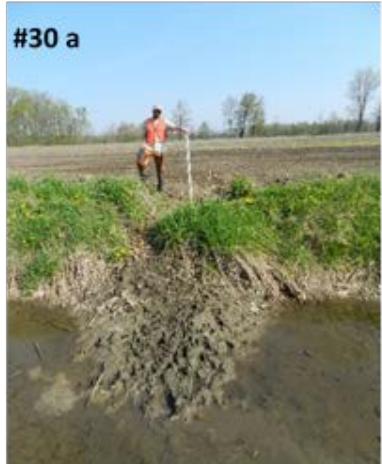
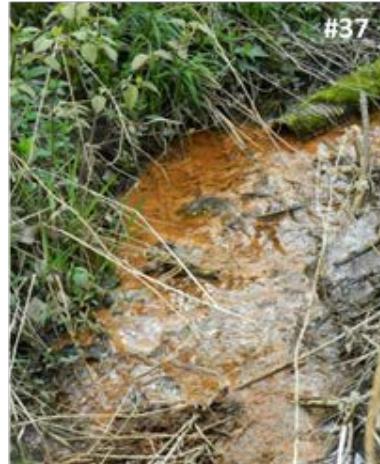
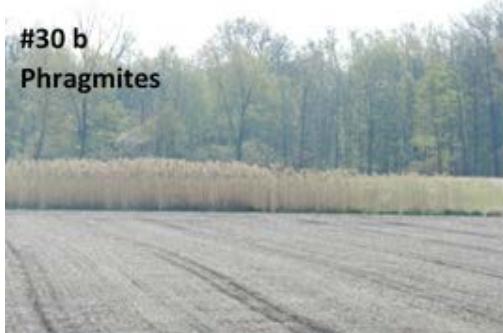
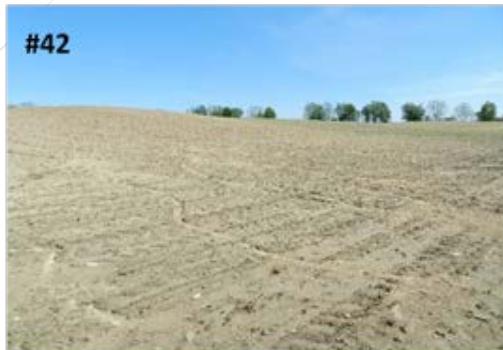
Figure 3.9 Photos from stream reconnaissance survey of the Headwaters Watershed 2014-2016.
 Source: Shiawassee Conservation District. 27 – Algal growth, red tint to water color and a sheen on the surface; 33 – Streambank erosion; 30 a – Gully at a deer crossing; 37 – Algae covering the substrate; 30 b – Invasive Phragmites stand; 42 – Rill erosion in crop field with little to no residue cover; 35 – Trash and yard waste pile near streambank; 39 – Tile outlet failure created a gully, outlet water with white foam, extensive algae

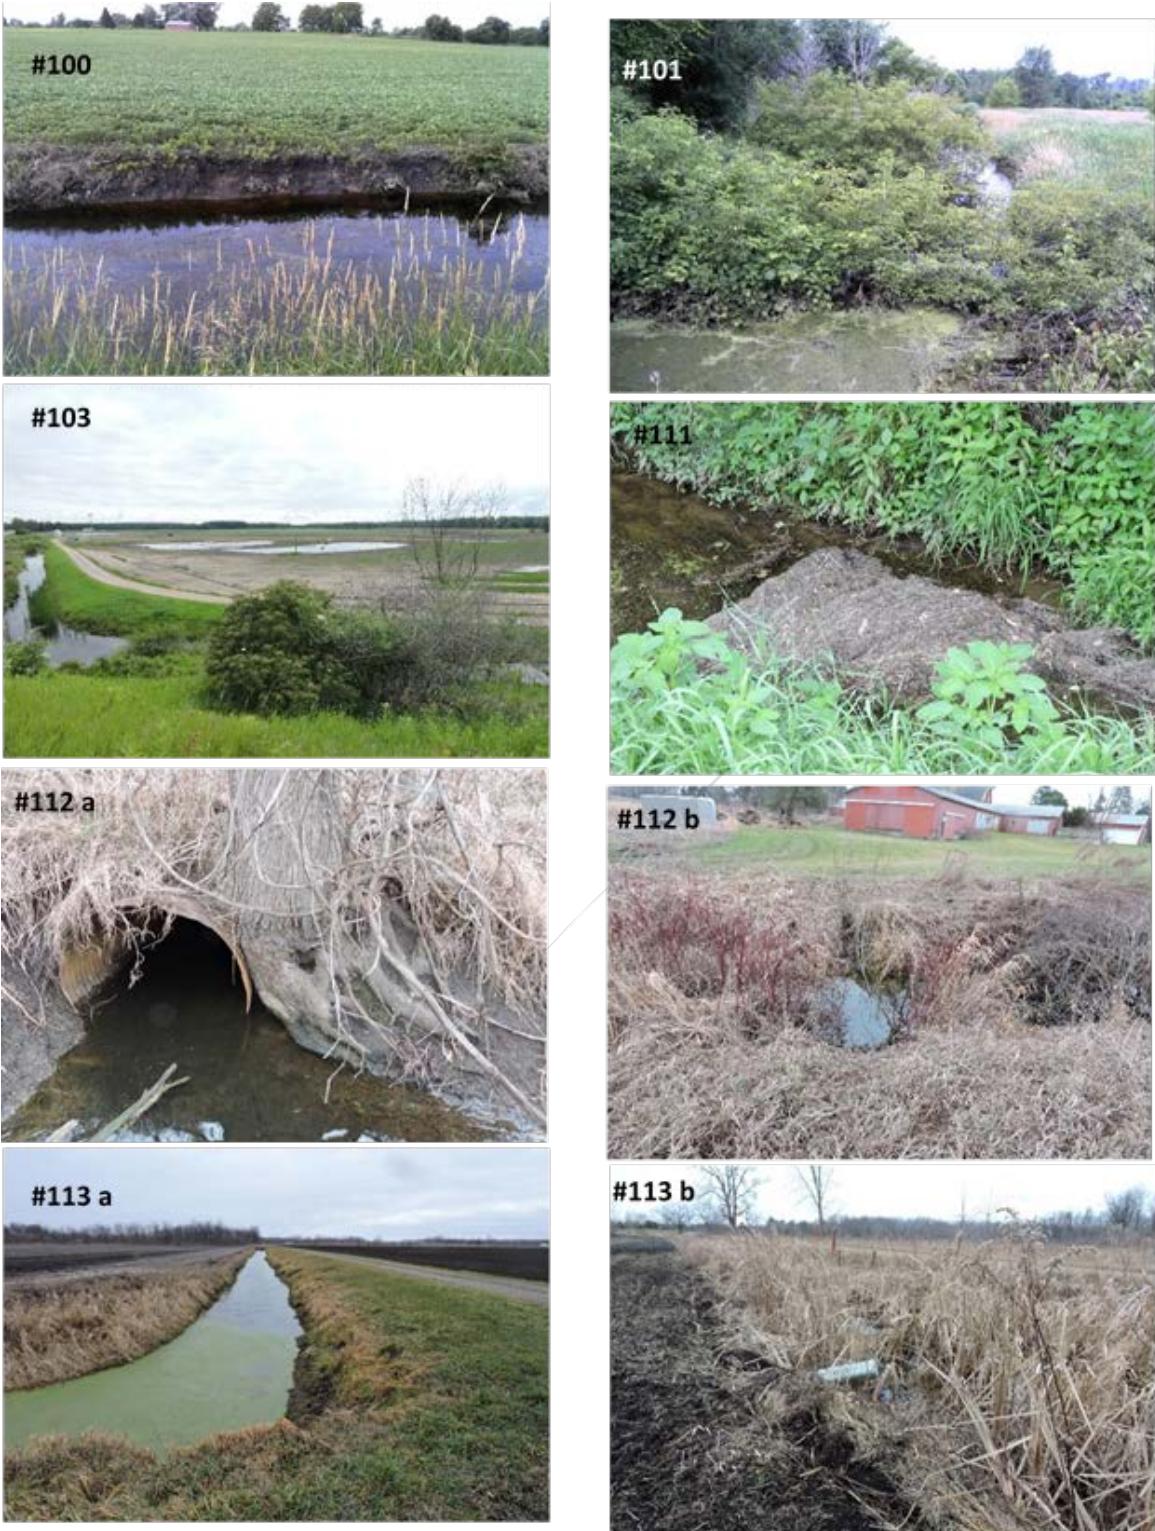
Figure 3.10 Photos from stream reconnaissance survey of the Howard Drain Watershed 2014-2016. Source: Shiawassee Conservation District. 100 – Producer plants to the streambank, no buffer, streambank erosion; 101 – Stream clogged up with debris and plant growth, extensive algae; 103 – Bare soil with sheet and rill erosion; 111 – Accumulation of debris in stream channel; 112 a – Tree roots growing around culvert; 112 b – Deer crossing created a gully; 113 a - Extensive duckweed and algae, inadequate buffer; 113 b – No buffer

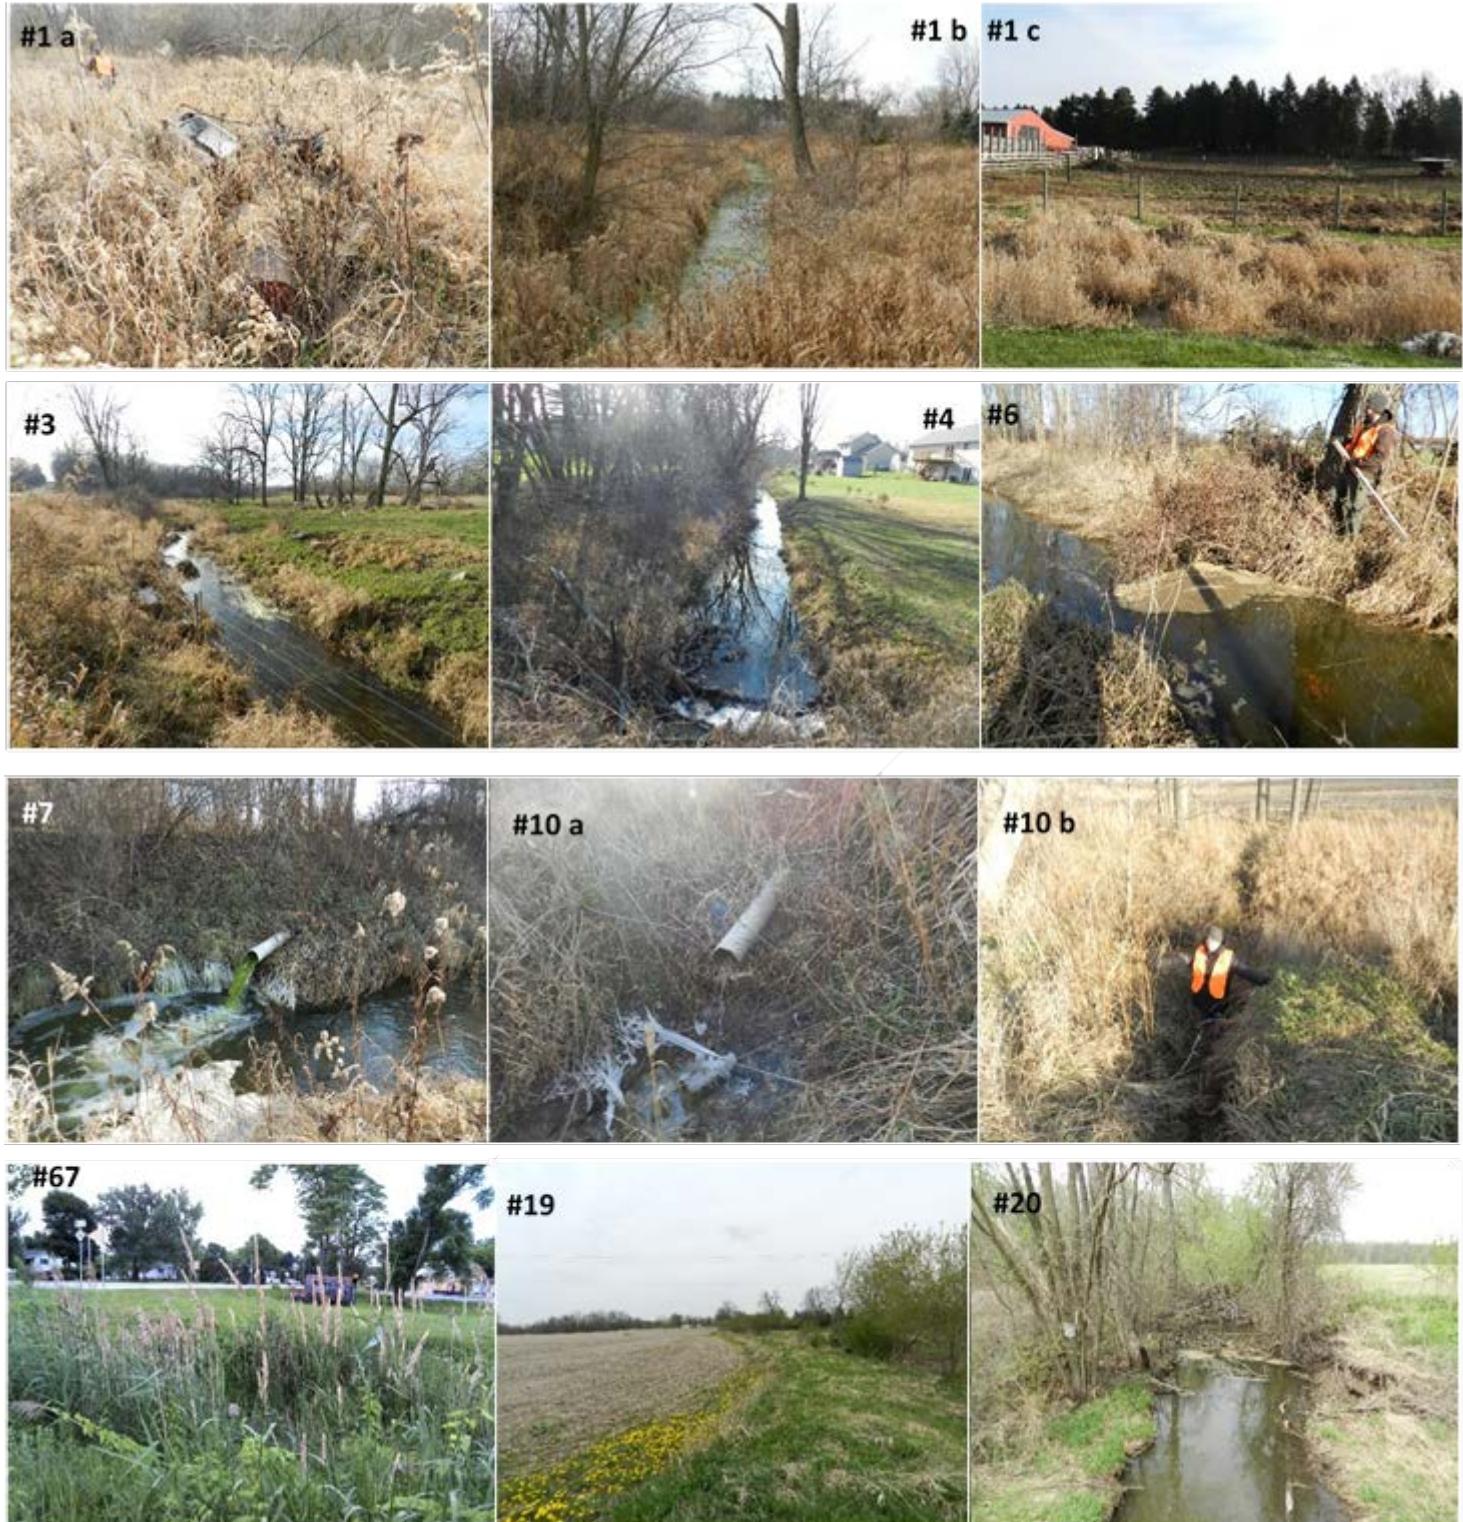
Figure 3.11 Photos from stream reconnaissance survey of the Kellogg Drain Watershed 2015-2016. Source: Shiawassee Conservation District. 1 a – Trash pile near stream; 1 b – Extensive aquatic plant growth; 1 c – Livestock lot adjacent to stream with inadequate buffer; 3 – Livestock pasture with uncontrolled access to stream; 4 – Residential mowing to streambank, inadequate buffer, white foam buildup in water; 6 – Buildup of a tan colored foam; 7 – Green colored water flowing out of outlet pipe; 10 a – Tile outlet created a gully; 10 b – Large gully; 67 – Invasive Phragmites and reed canary grass; 19 – Adequate buffer; 20 – Lots of debris in stream

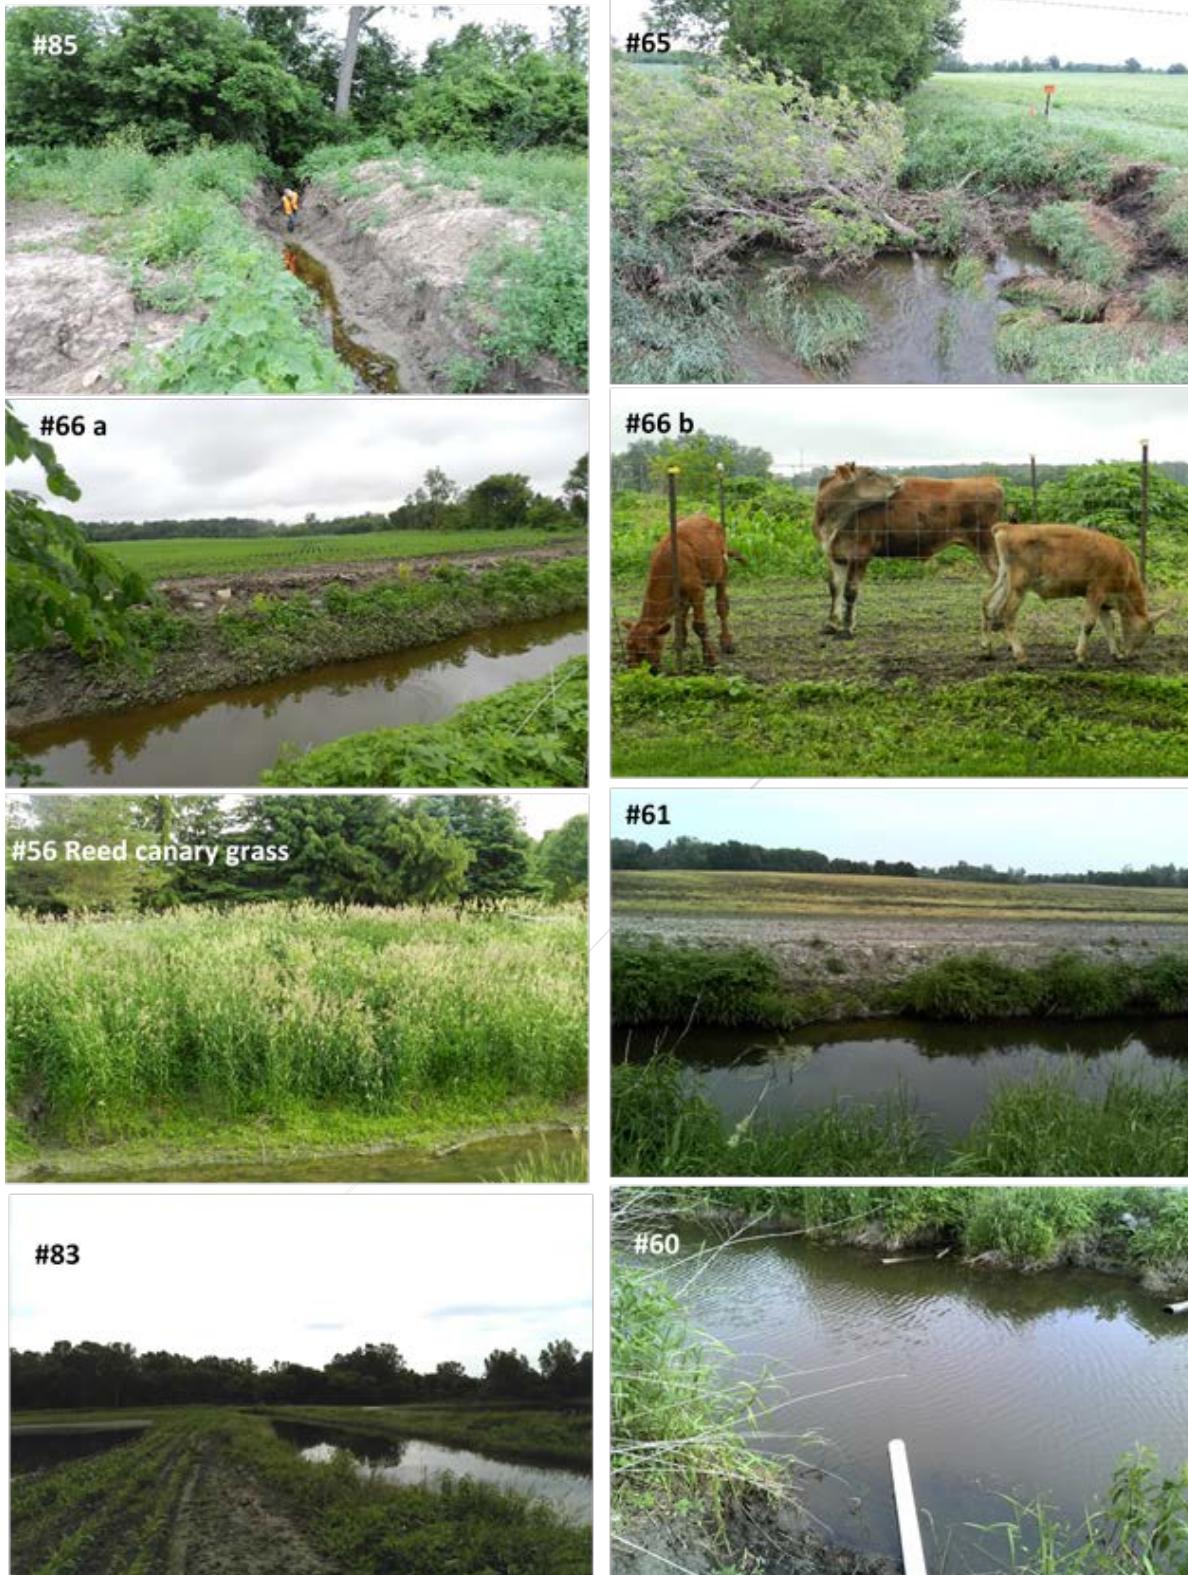
Figure 3.12 Photos from stream reconnaissance survey of the Buck Branch Watershed 2015-2016. Source: Shiawassee Conservation District. 85 – Extensive gully erosion; 65 – Excessive undercutting and streambank erosion caused tree to fall into stream; 66 a – No buffer; 66 b – Livestock adjacent to stream; 56 – Invasive reed canary grass; 61 – Tilled to streambank, no buffer; 83 – Streambank overflow caused ponding in crop field, inadequate buffer; 60 – Multiple tile outlets with evidence of erosion above outlets

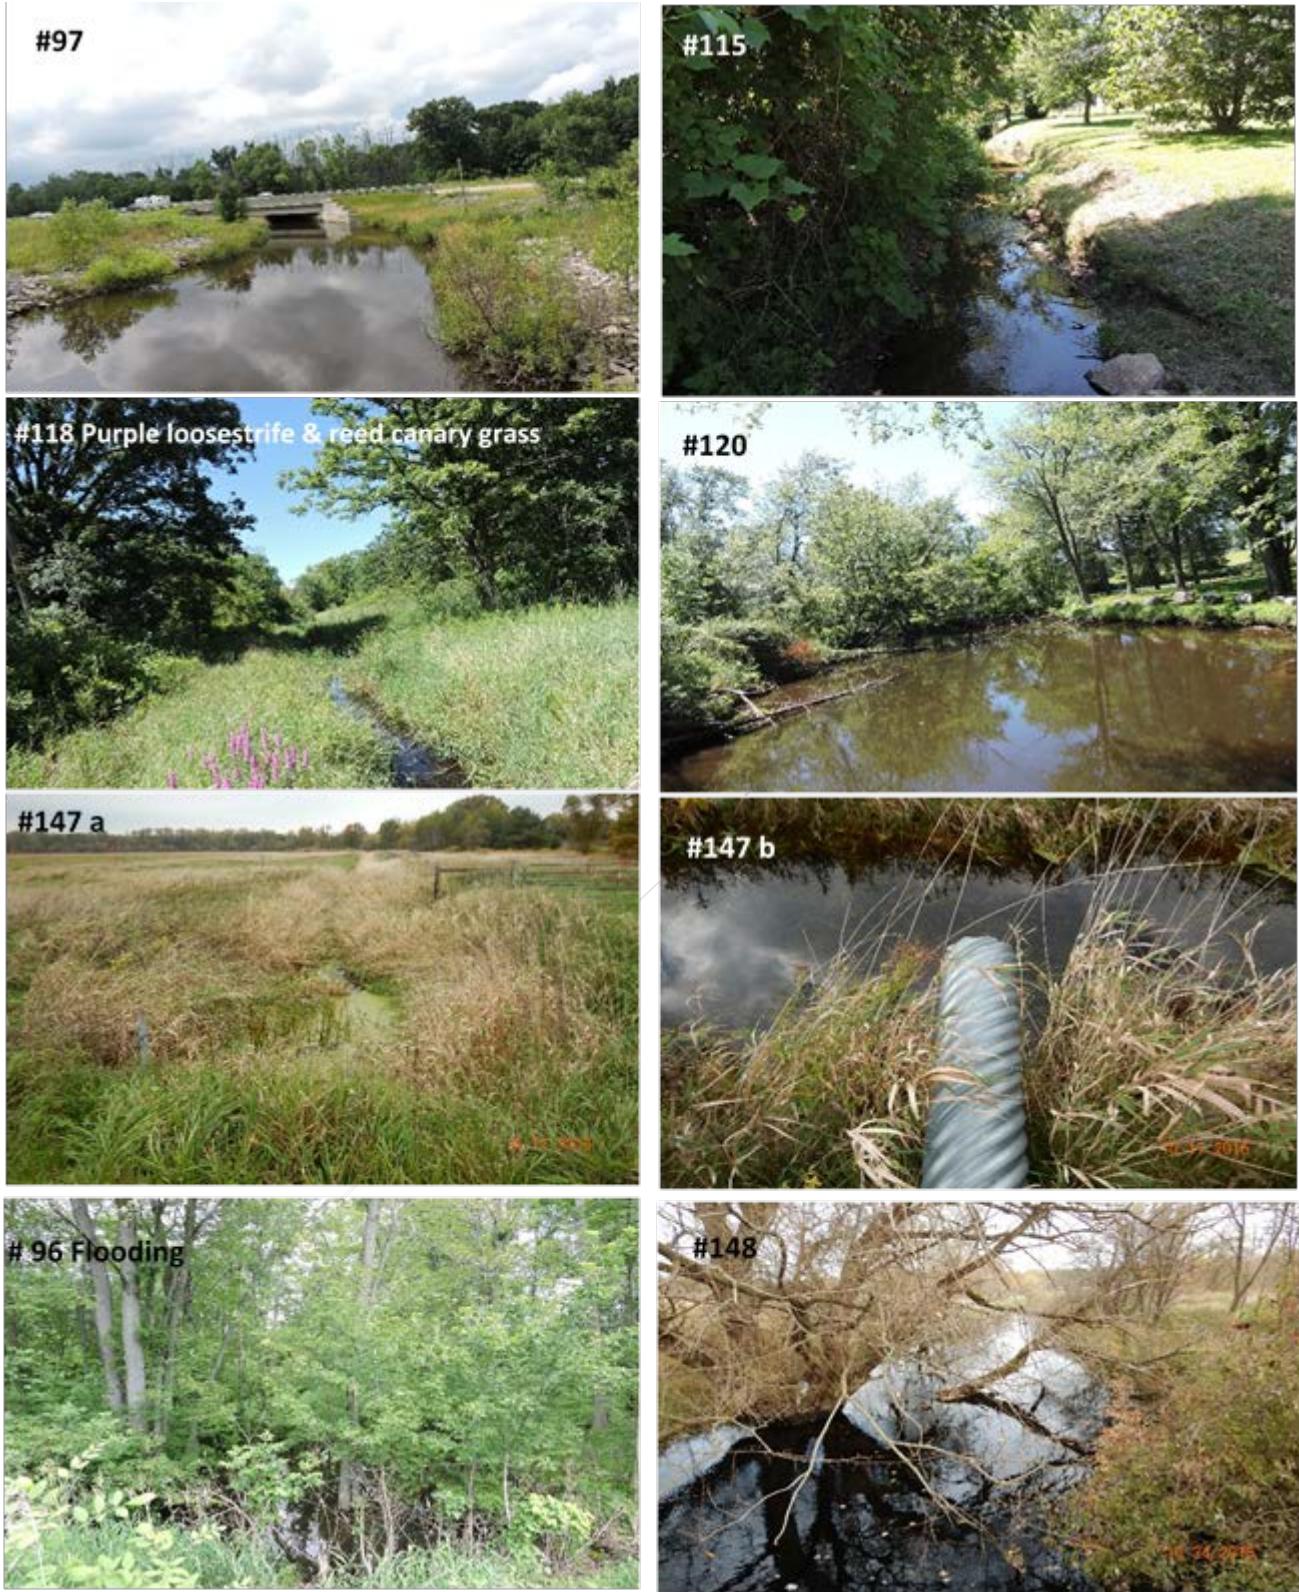
Figure 3.13 Photos from stream reconnaissance survey of the Vermillion Creek Watershed 2015-2016.
Source: Shiawassee Conservation District. 97 – I-69 passing over stream; 115 – No buffer on left bank, mowing to streambank; 118 – Invasive purple loosestrife and reed canary grass; 120 – Lack of buffer, undercutting of left streambank; 147 a – High duckweed density; 147 b – Drainage tile outlet; 96 – Flooded area adjacent to stream; 148 – Black colored water with high turbidity

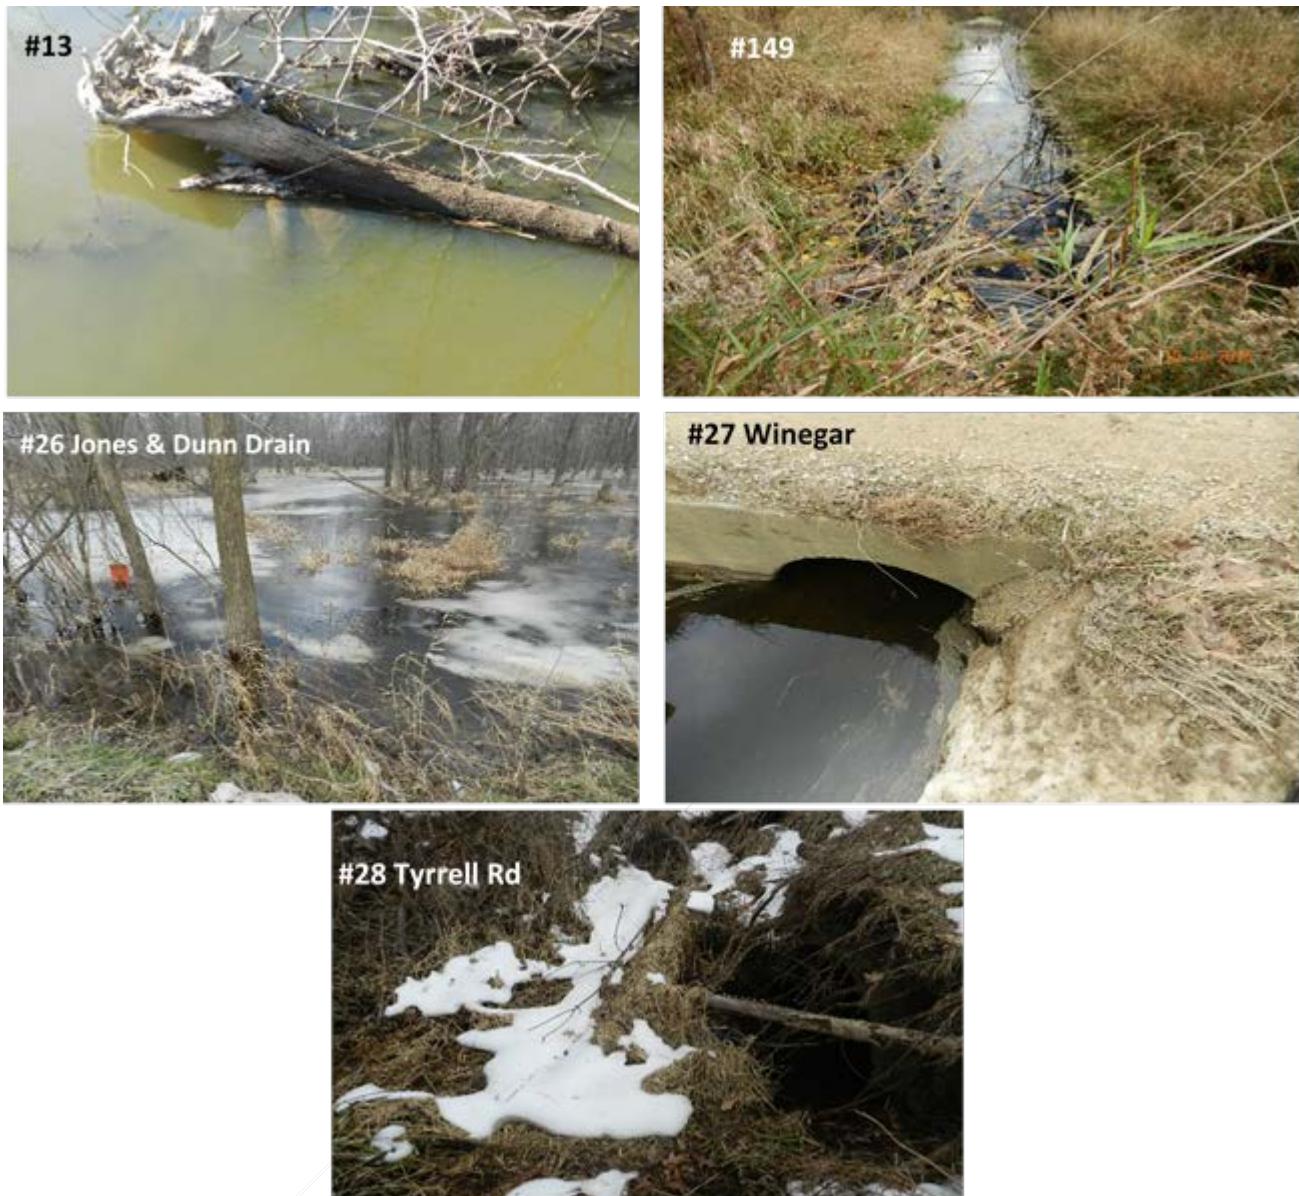
Figure 3.14 Photos from stream reconnaissance survey of the Leisure Lakes Watershed 2015-2016. Source: Shiawassee Conservation District. 13 – Deer carcass found in stream; 149 – Invasive reed canary grass; 26 – Flooded area of Jones & Dunn Drain; 27 – Short culvert, road right at stream, gravel from road eroding into stream; 28 – Stream and culvert obstructed

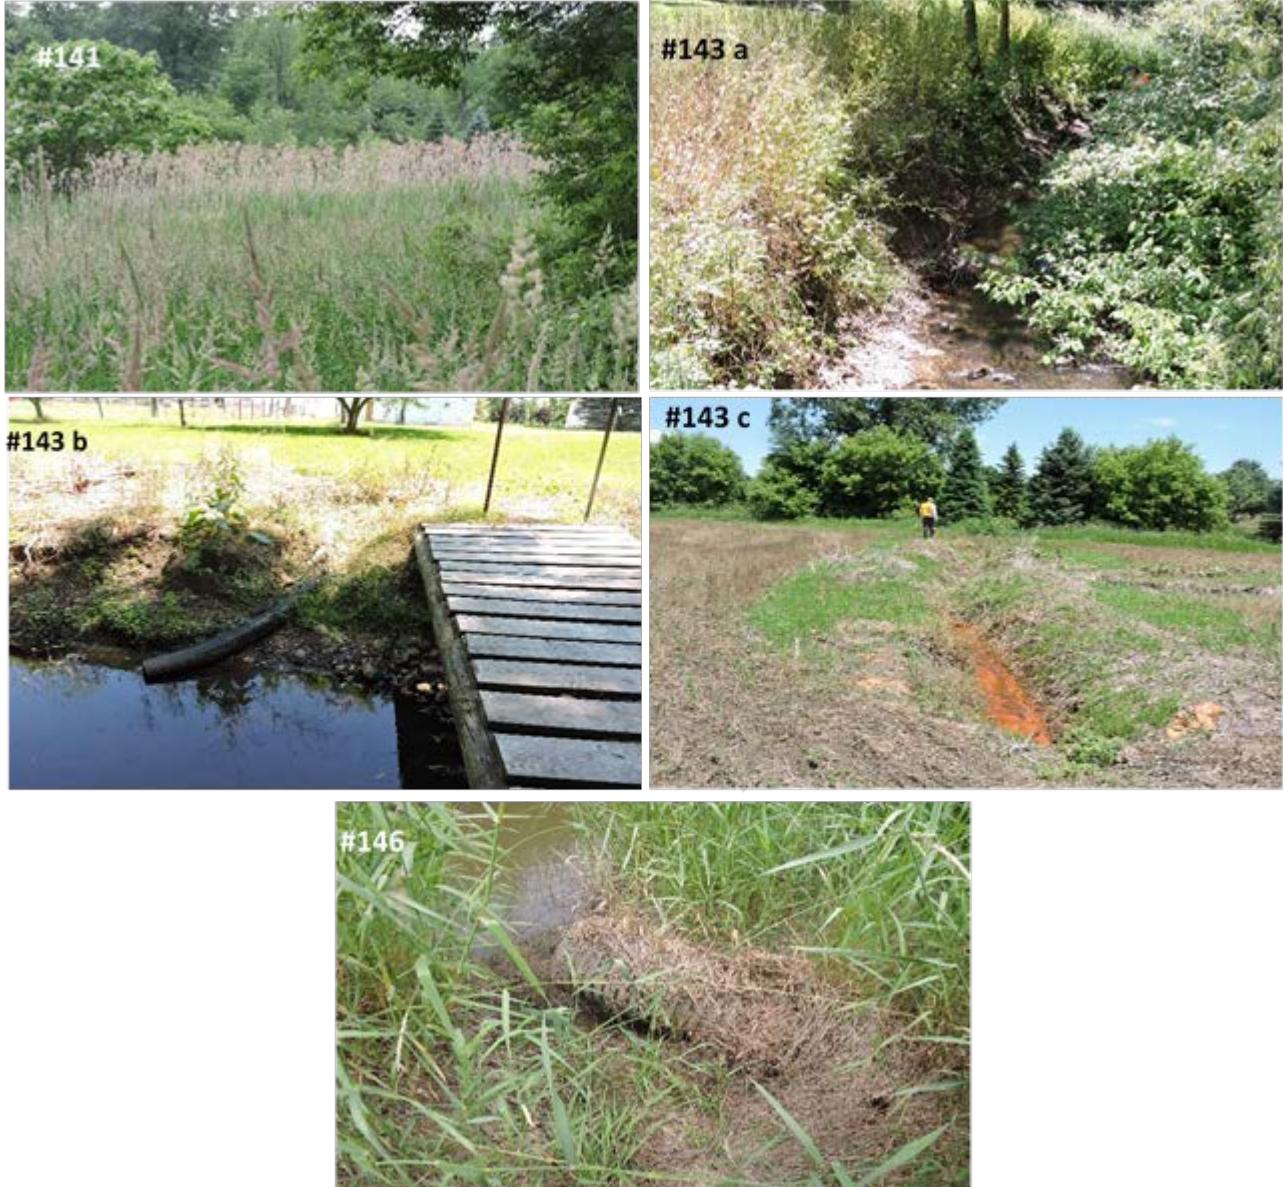
Figure 3.15 Photos from stream reconnaissance survey of the Mud Creek Watershed 2015-2016. Source: Shiawassee Conservation District. 141 – Invasive Phragmites and reed canary grass; 143 a – Invasive garlic mustard and Dame's rocket along streambank; 143 b – Streambank erosion, failed drainage outlet, gully erosion and inadequate buffer; 143 c – Tile failure that created a gully over 80ft in length; 146 – Drainage outlet causing erosion at the streambank

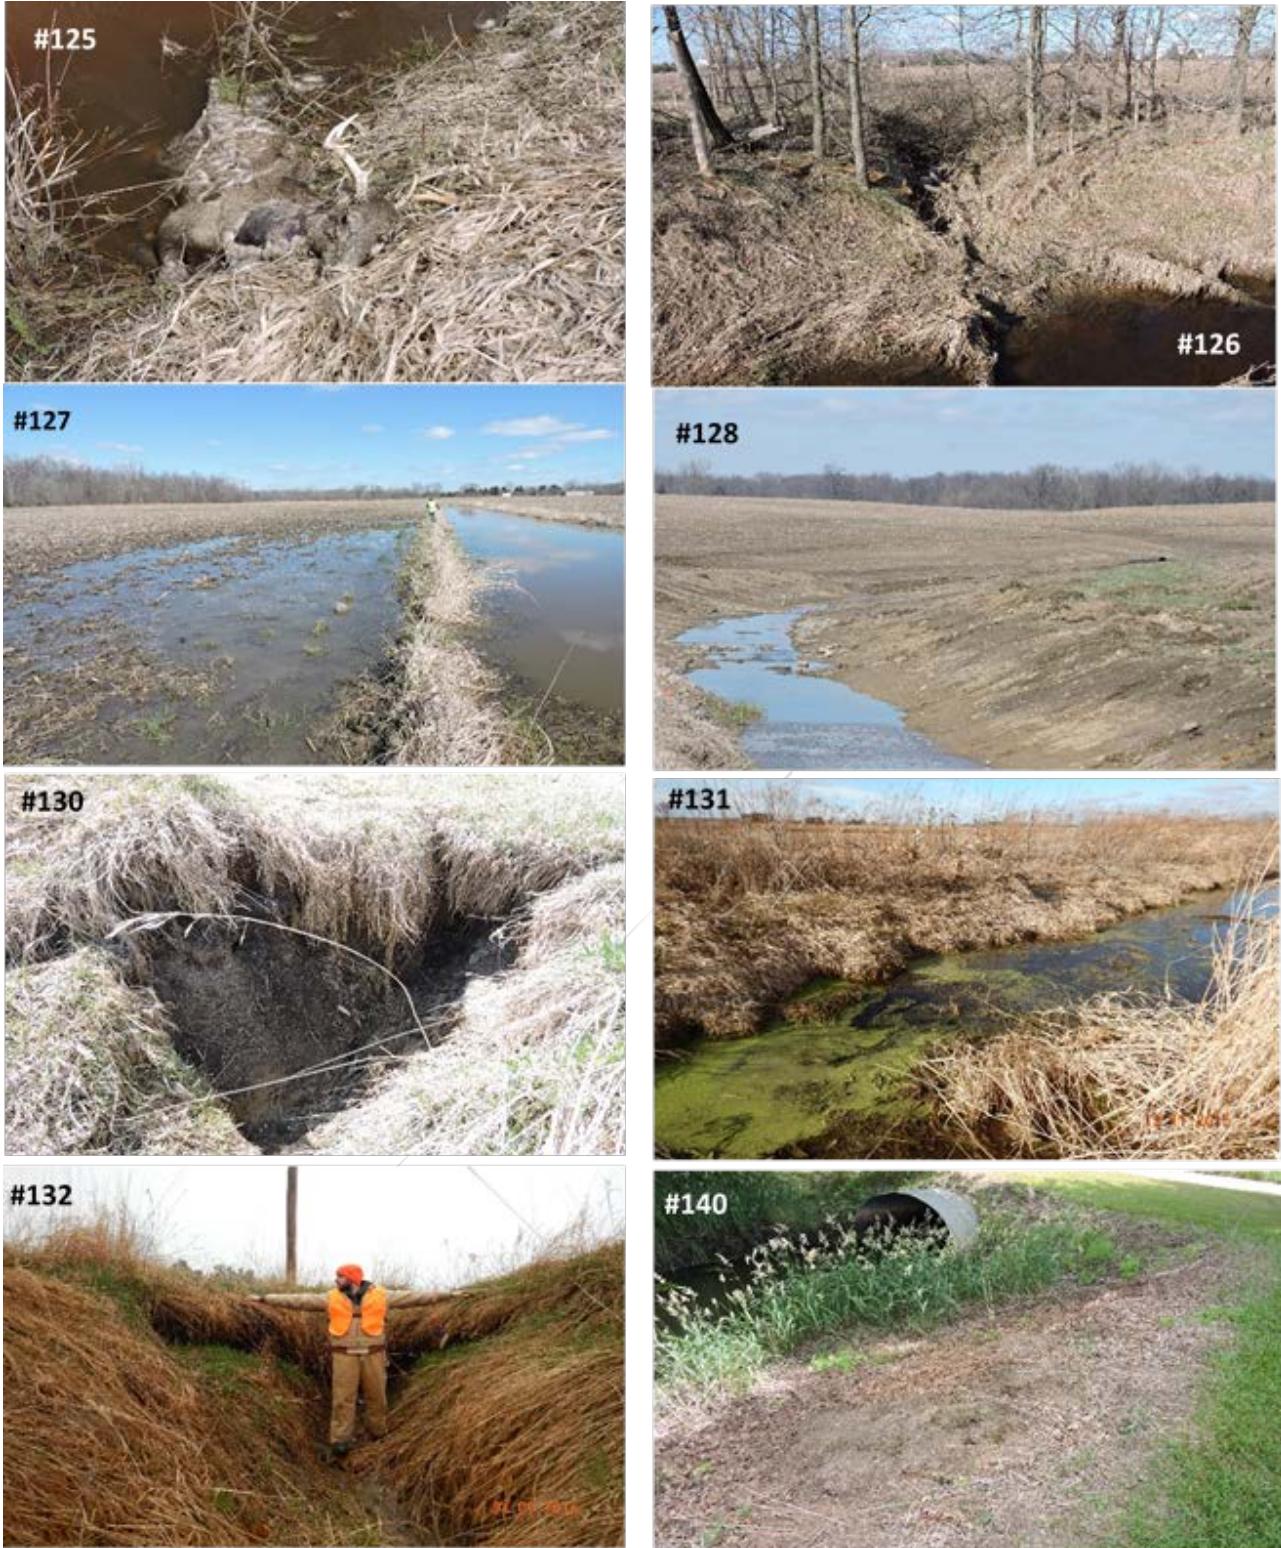
Figure 3.16 Photos from stream reconnaissance survey of the Turkey Creek Watershed 2015-2016. Source: Shiawassee Conservation District. 125 – Deer carcass found in stream; 126 – Large gully originating from crop field; 127 – Stream flooding into crop field, little to no buffer; 128 – Dredged stream with little to no buffer, conventional tillage on adjacent crop land; 130 – Tile failure that created a large gully at the streambank; 131 – Excess duckweed and algal growth; 132 – Tile failure that created a very large gully leading to streambank; 140 – Yard waste dumped along streambank with little buffer

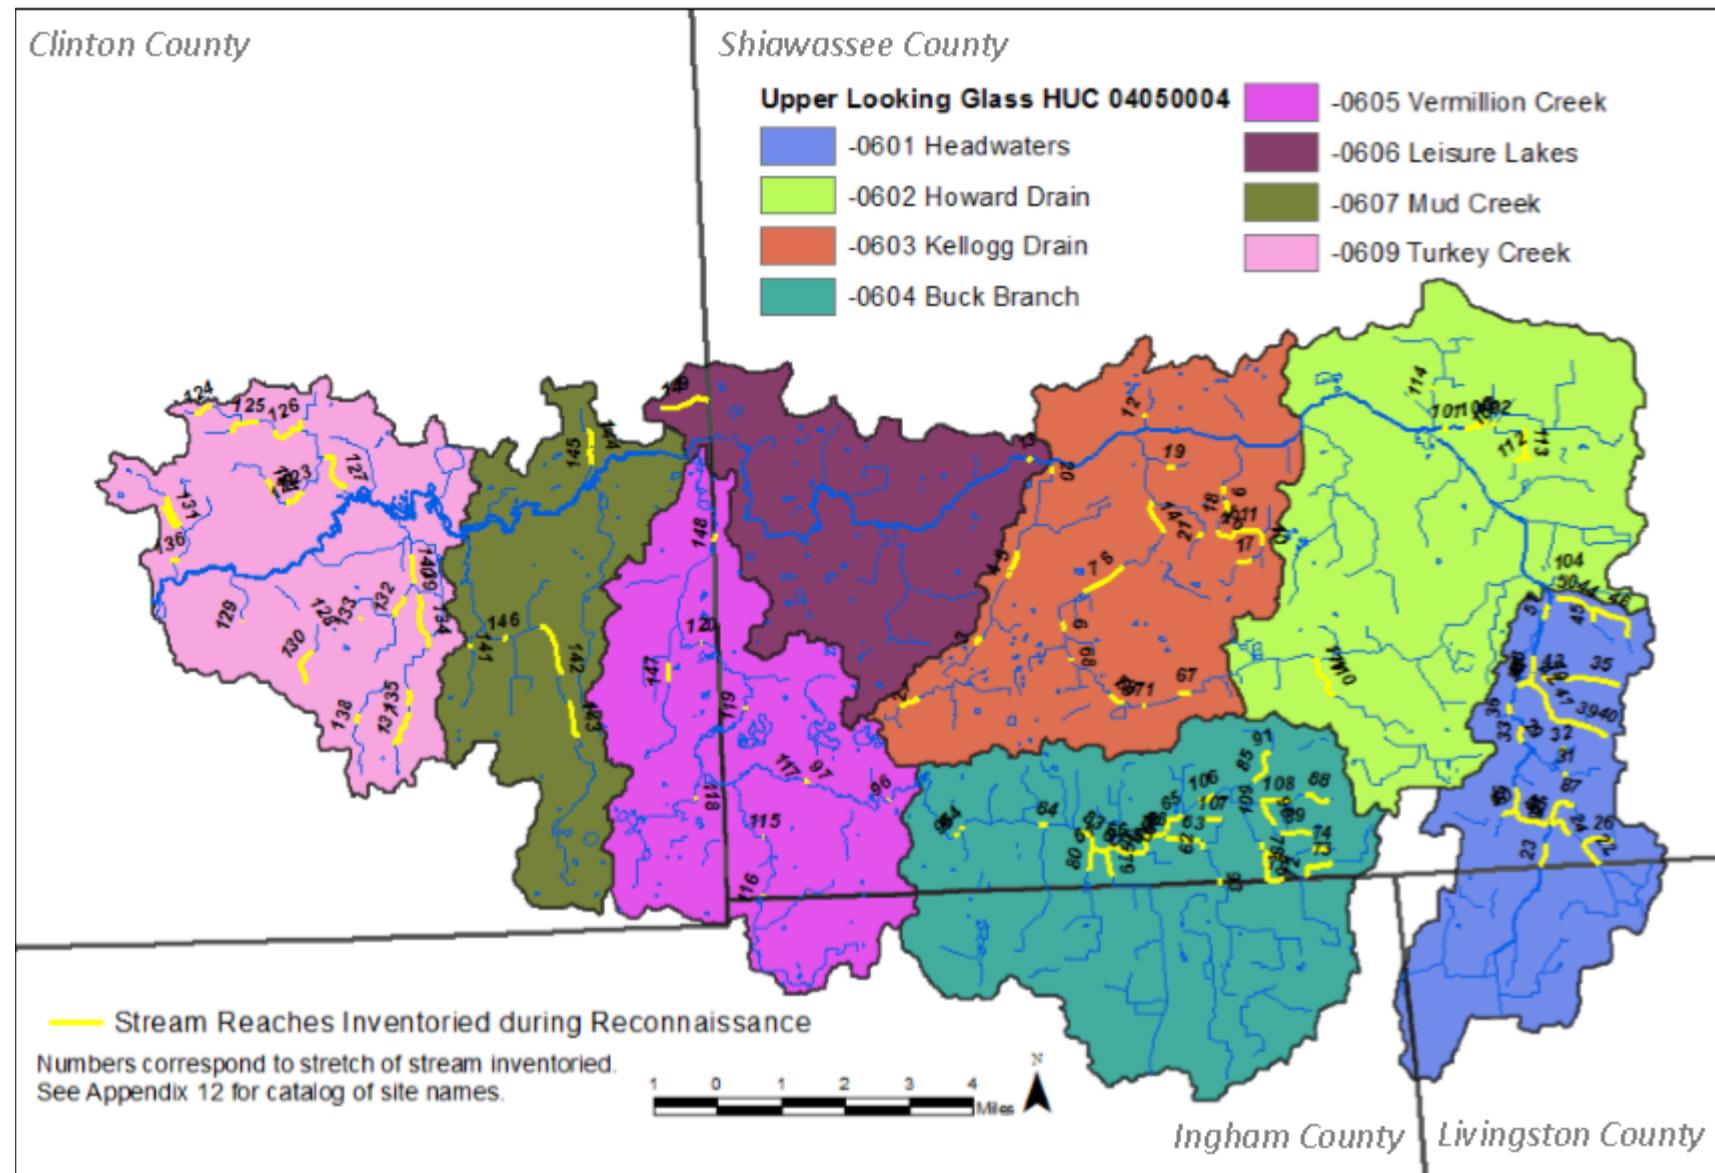
Figure 3.17 Surveyed areas in the Upper Looking Glass River Watershed during the Stream Reconnaissance Survey, Fall 2014 through Winter 2016.

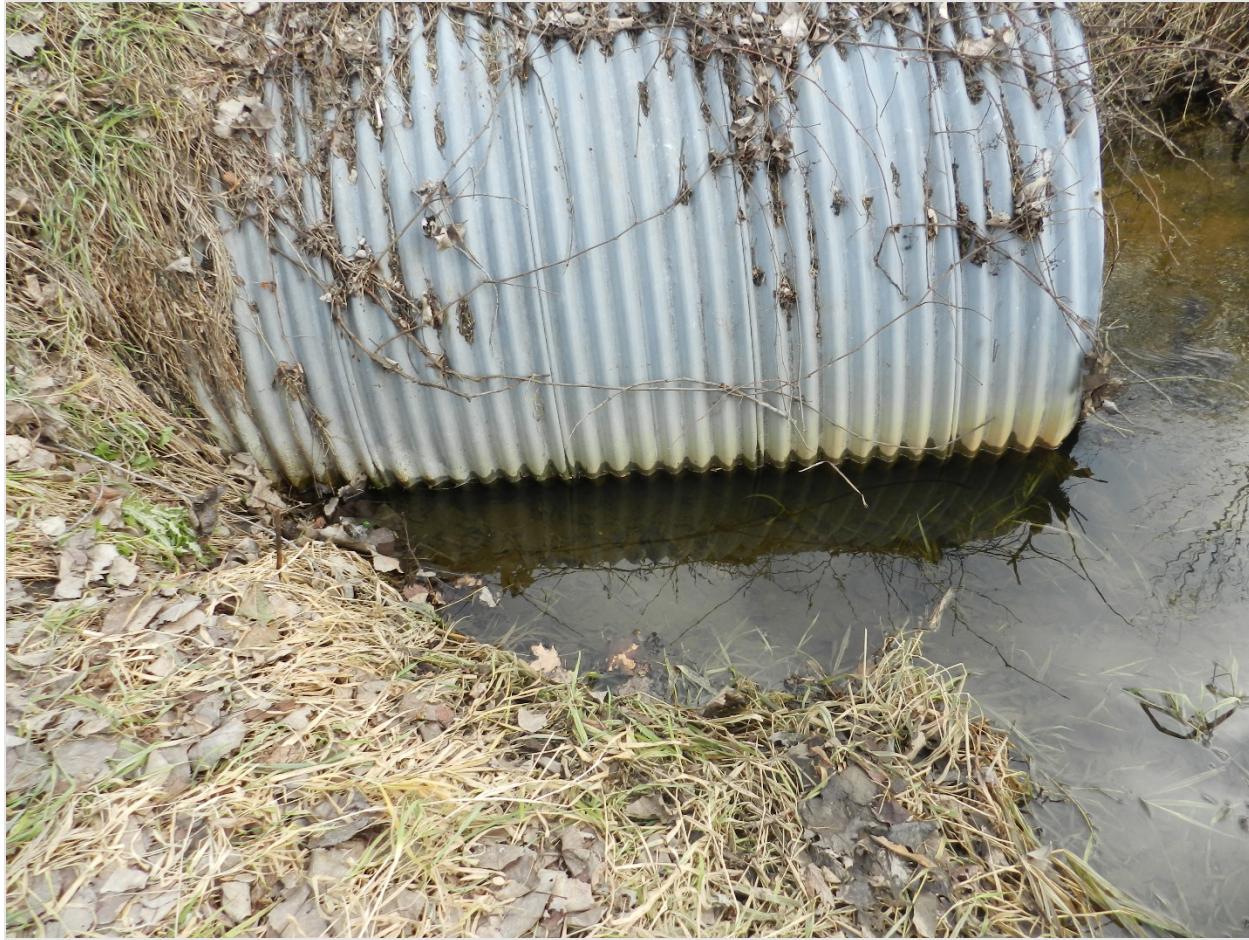
Figure 3.18 Upstream ponding from an undersized and perched culvert, Howard Drain culvert at Tyrrell Road – Howard Drain sub-watershed, Shiawassee County, Site 23.

Over half of crossings surveyed had upstream ponding indicating that crossing structures are undersized. In contrast, less than a third had scour pools, potentially due to the flat topography, and therefore, a slow-moving nature to the watershed's drainage. Fish passage may be a minor issue; perched culverts comprise 10% of the surveyed crossings. Figure 3.18 depicts an example of road crossing upstream ponding in the watershed.

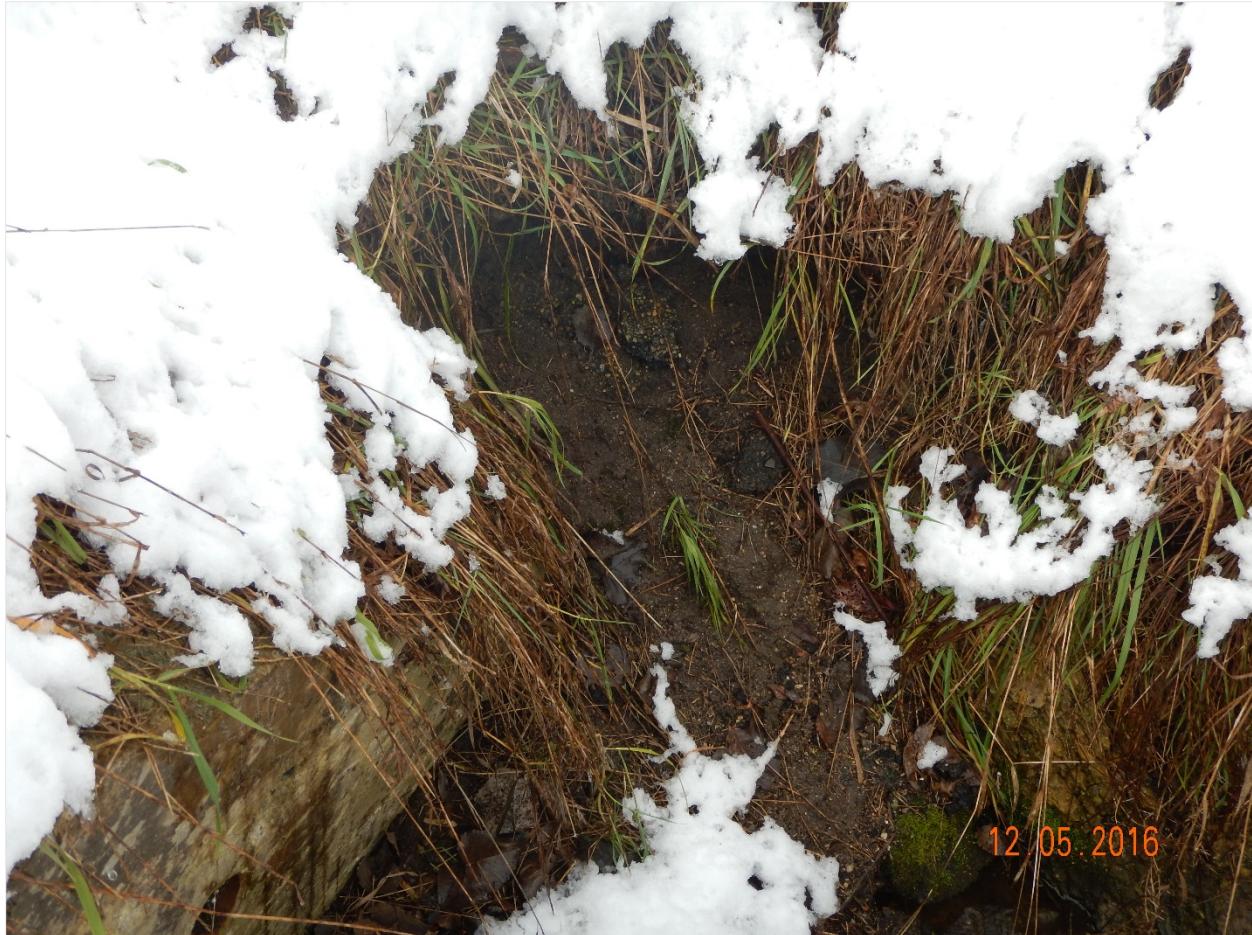
Figure 3.19 Severe gully erosion at Turkey Creek crossing at Cutler Road - Turkey Creek sub-watershed, Clinton County, Site 37.
