Upper Looking Glass River Watershed Management Plan

January 16, 2018

**Shiawassee Conservation
District**

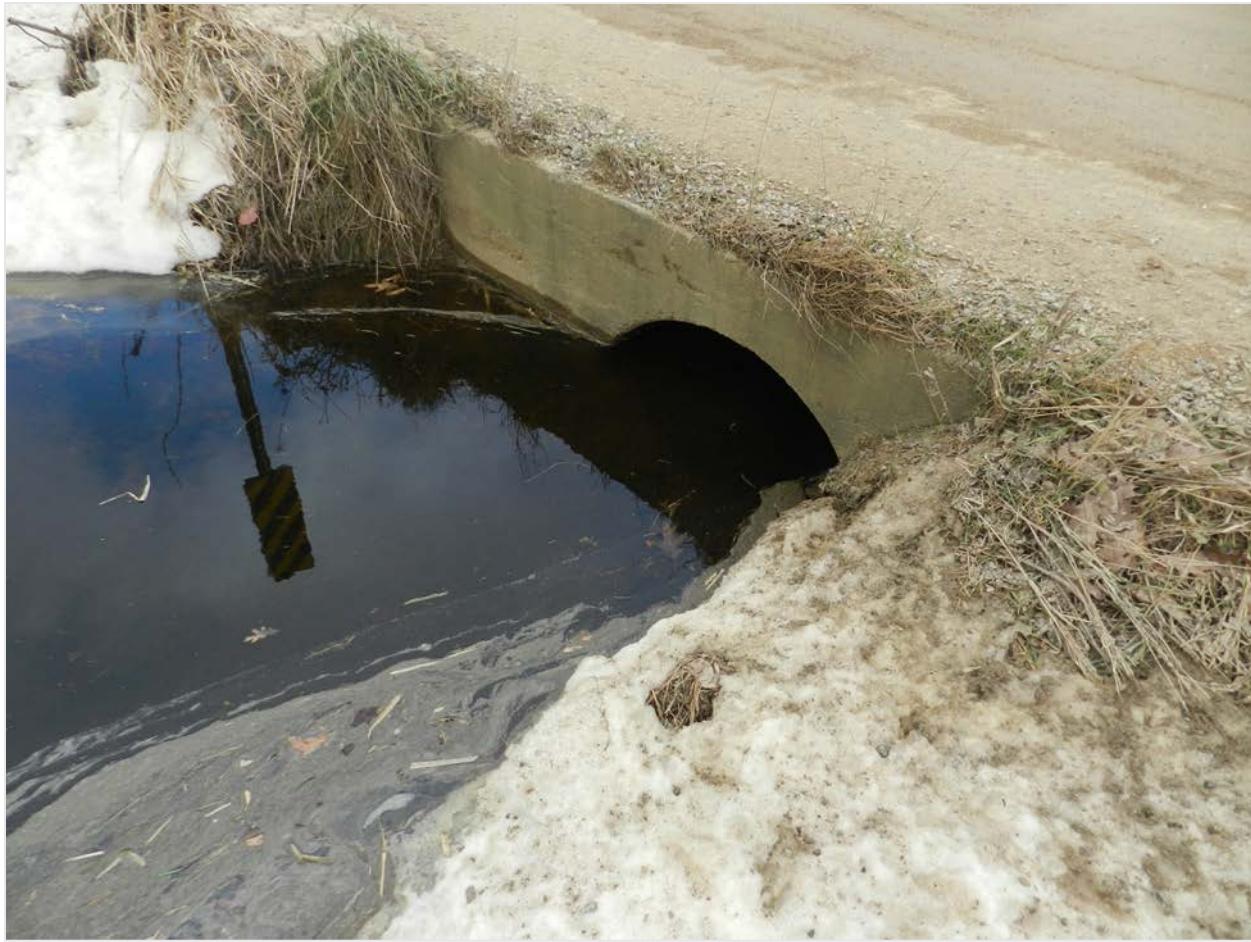
Figure 3.20 Road gravel eroding directly into waterway at unknown stream crossing at Winegar Road - Leisure Lakes sub-watershed, Shiawassee County, Site 27.

Gravel roads make up 68% of the road surfaces at the survey sites. As compared to crossings with paved road surfaces, maintenance of gravel road surfaces can play a significant role in the integrity of a road-stream crossings with gravel surfaces. Improper crossing construction can lead to easy flow paths from the roadway into the stream. Two crossings have road gravel that falls directly into the waterway (See Figure 3.20). Erosion from roadways is potentially a large contributor to sediment and chemicals in the stream.

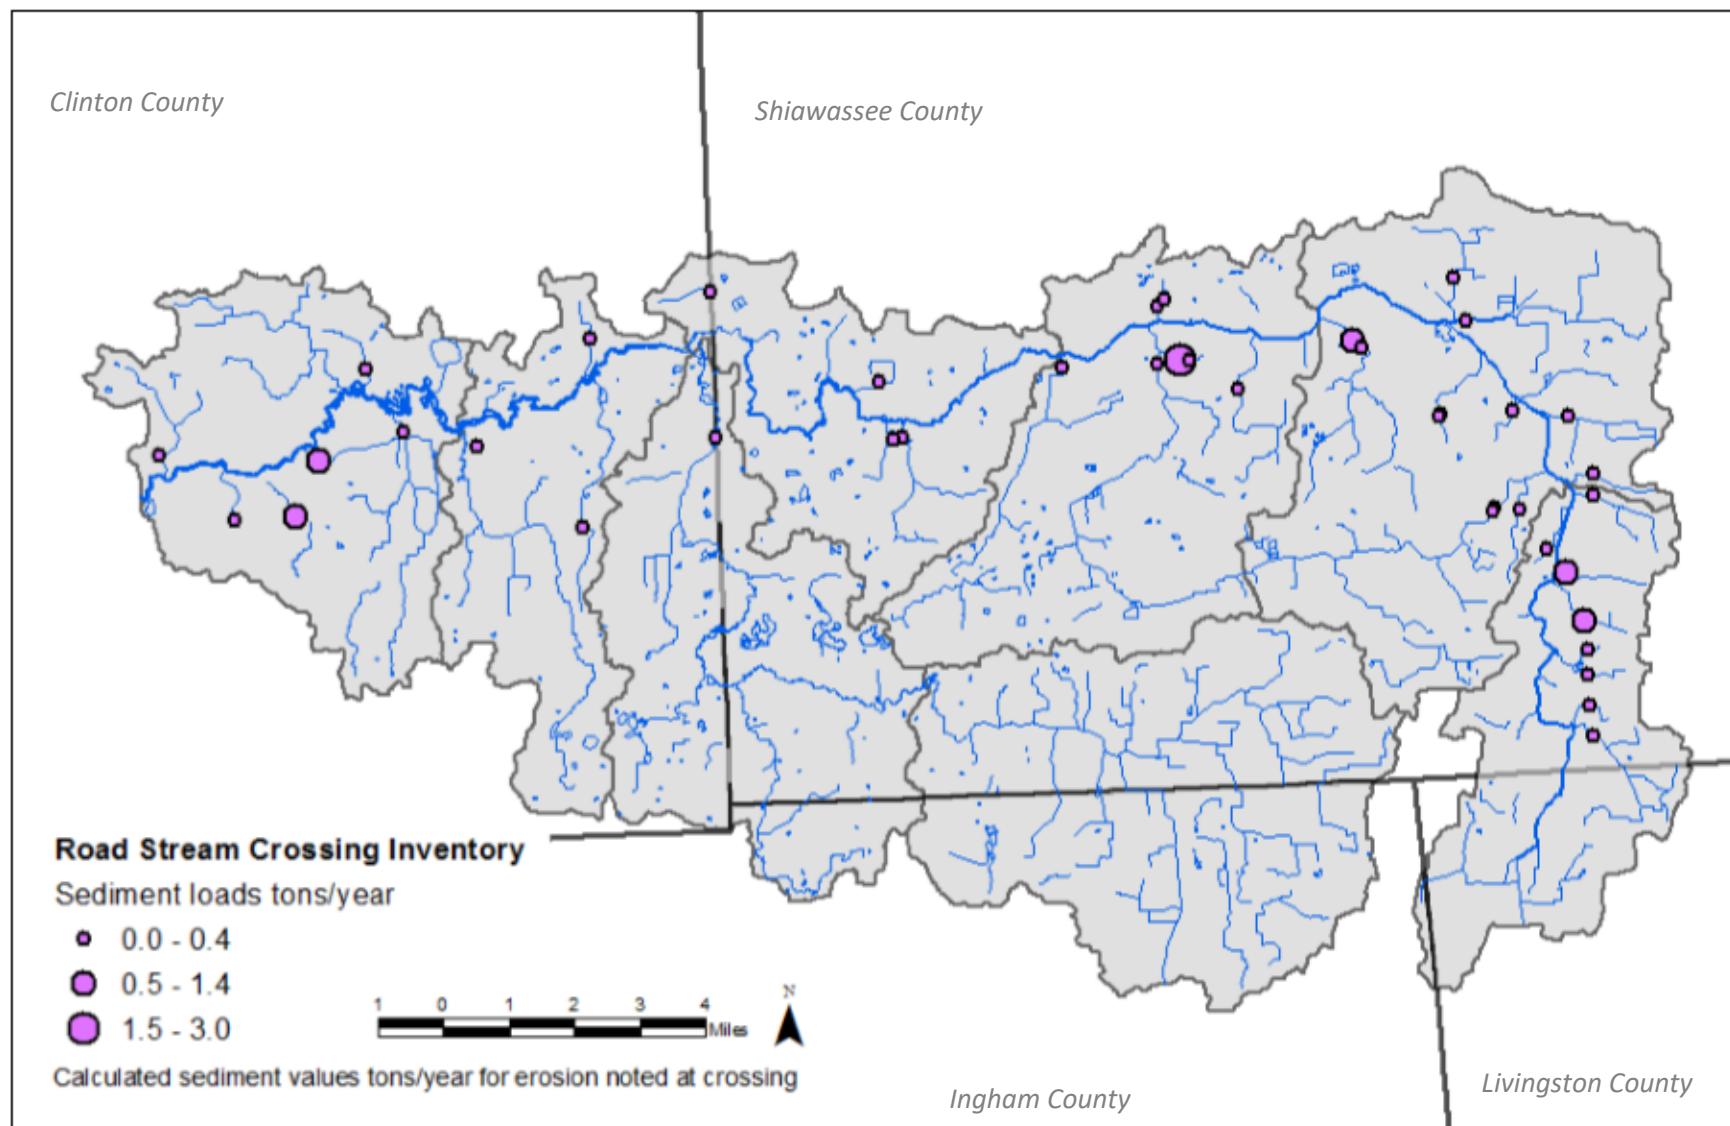
Figure 3.21 Road stream crossing inventory locations with sediment loss calculated (tons per year) for erosion noted at time of investigation in the Upper Looking Glass River Watershed, Winter 2016.

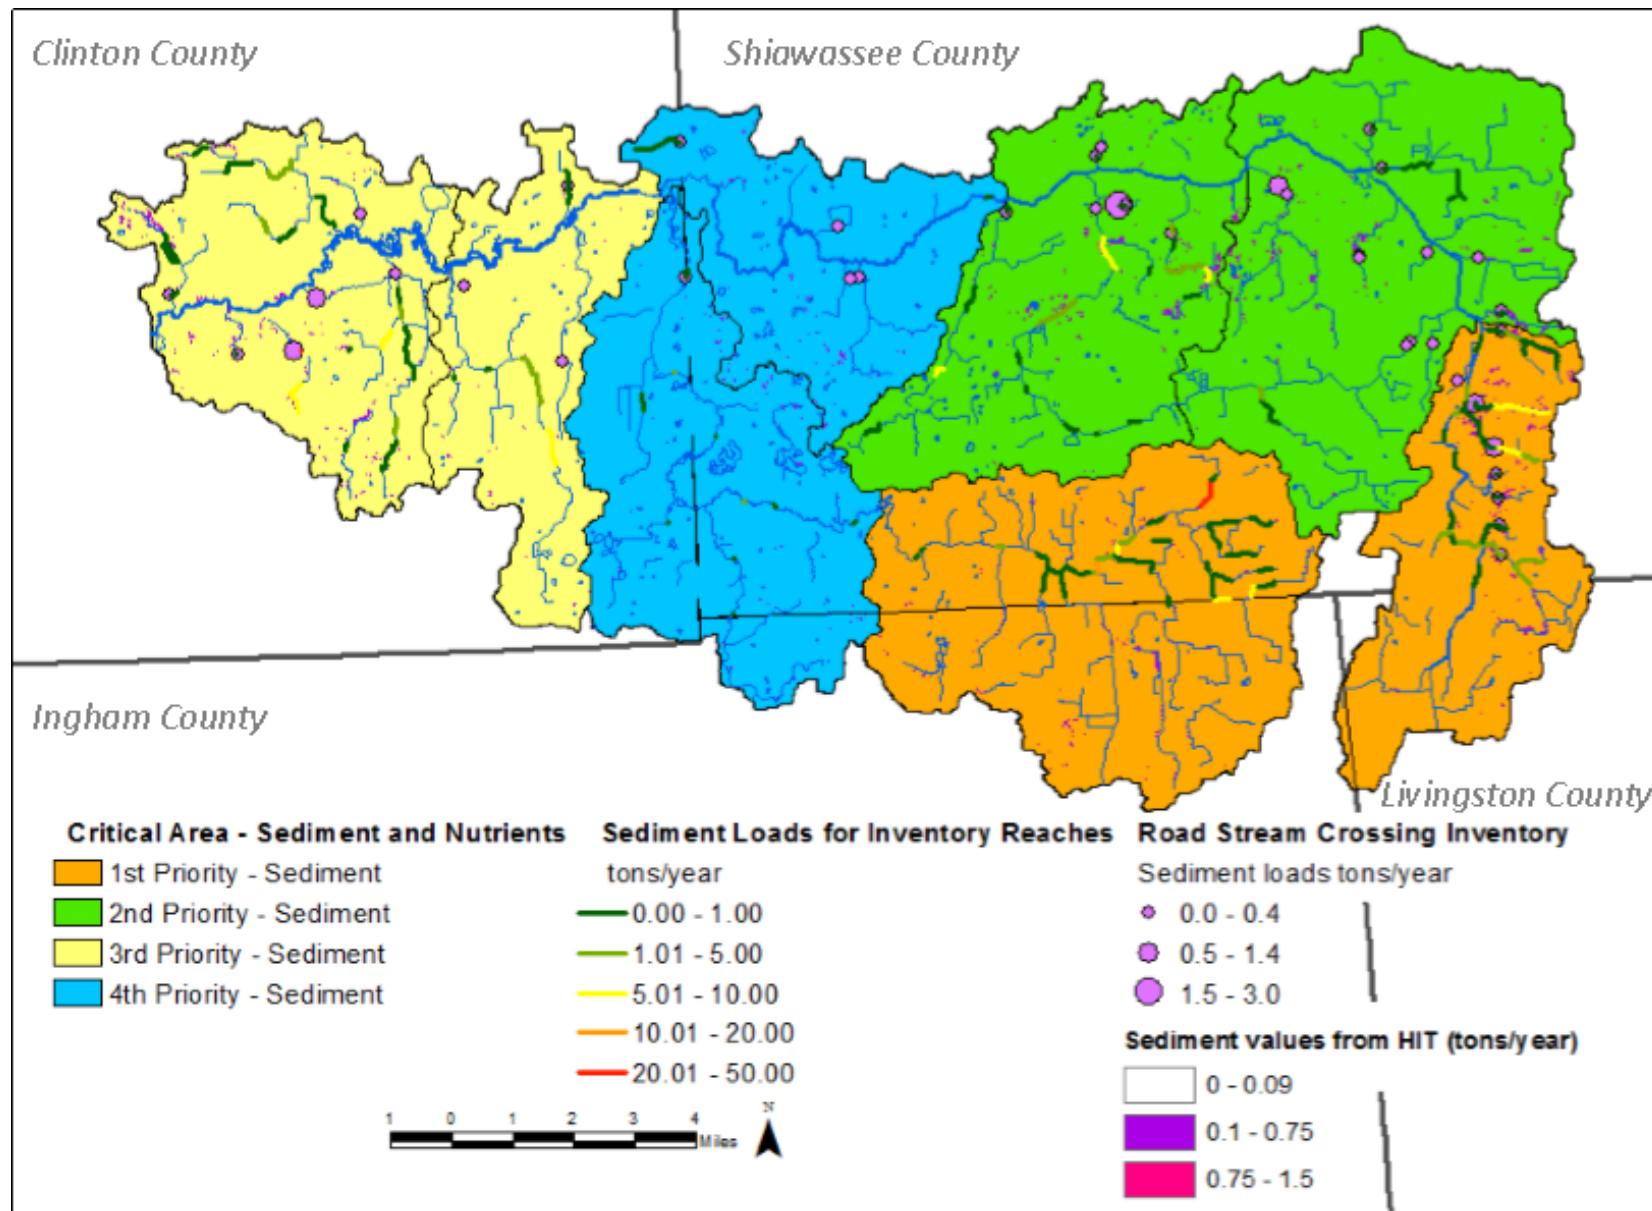
Figure 3.25 Sediment loads calculated from gully and streambank erosion noted during stream reconnaissance, gully loads from road stream crossing inventory, and sediment values estimated using HIT. Critical areas are identified based on calculated sediment loads from inventories described in 3.1.

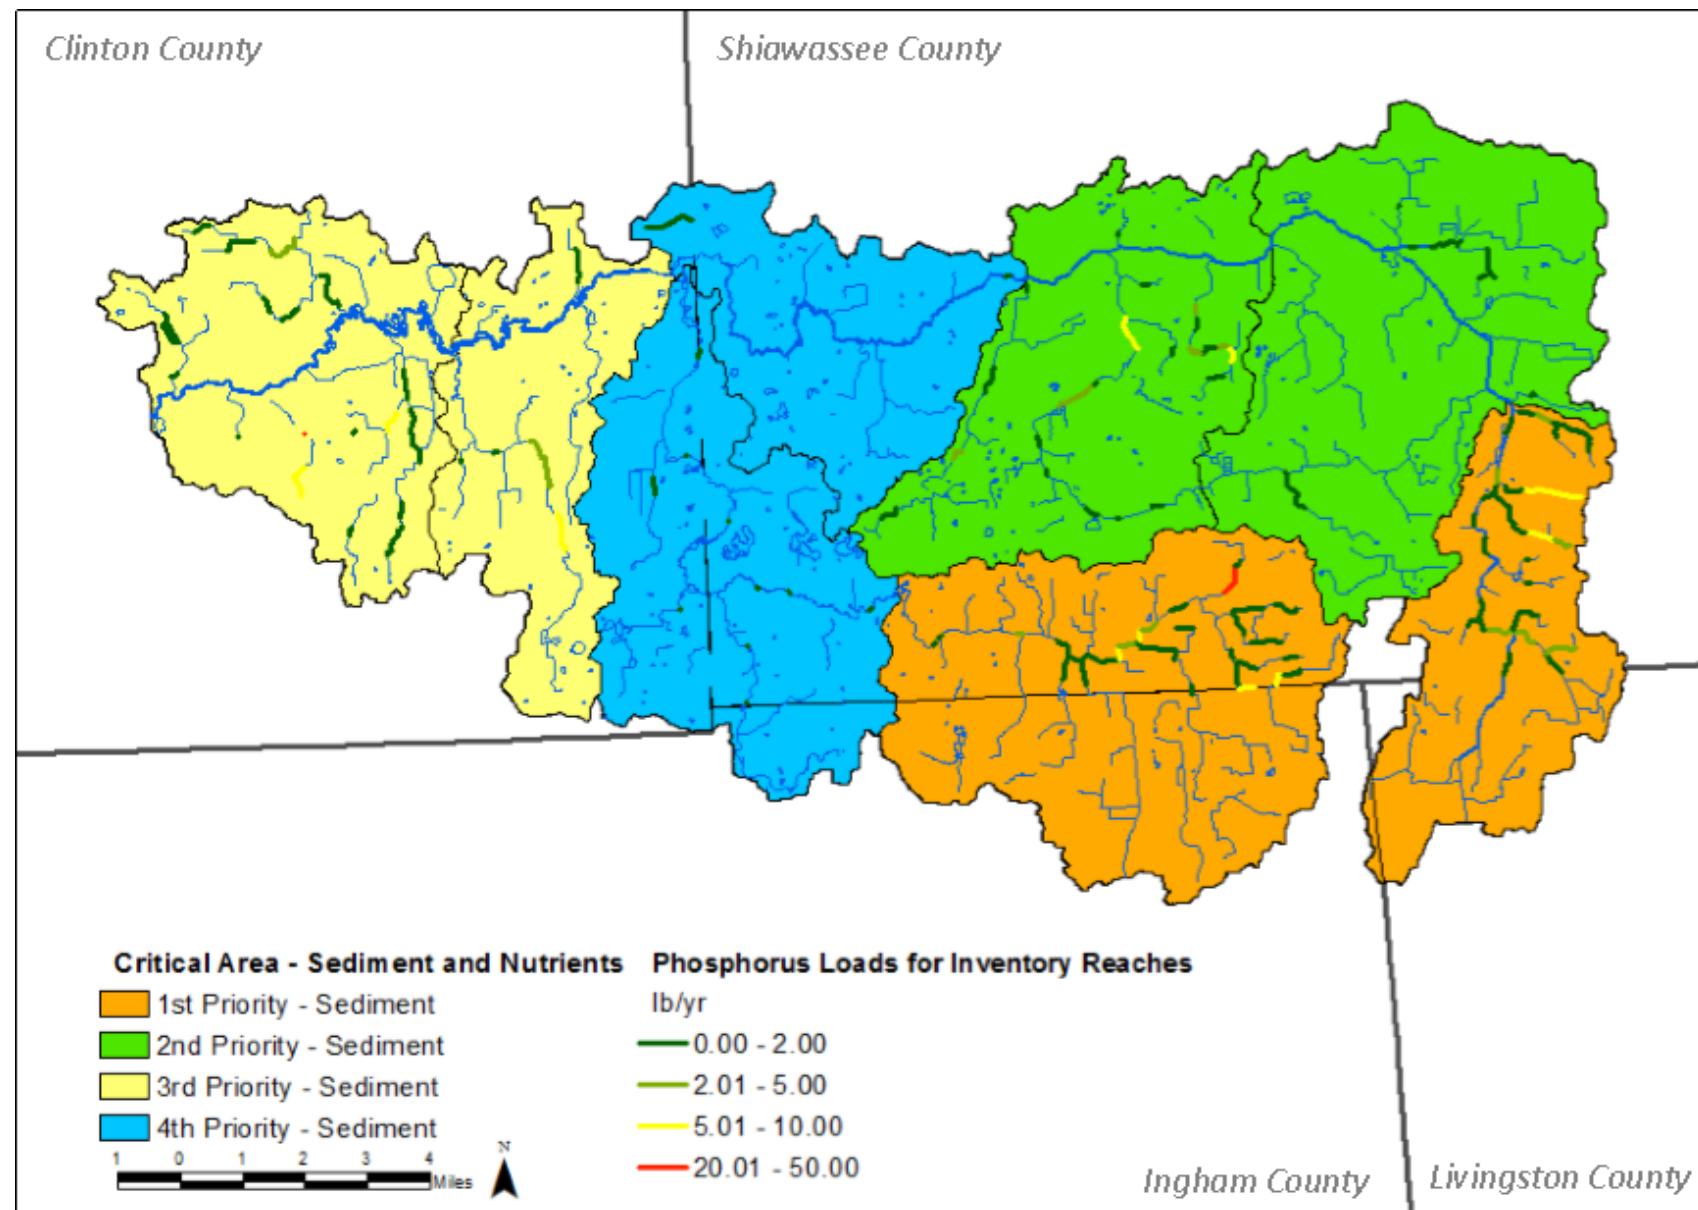
Figure 3.26 Phosphorus loads calculated from streambank and gully erosion noted during stream reconnaissance.

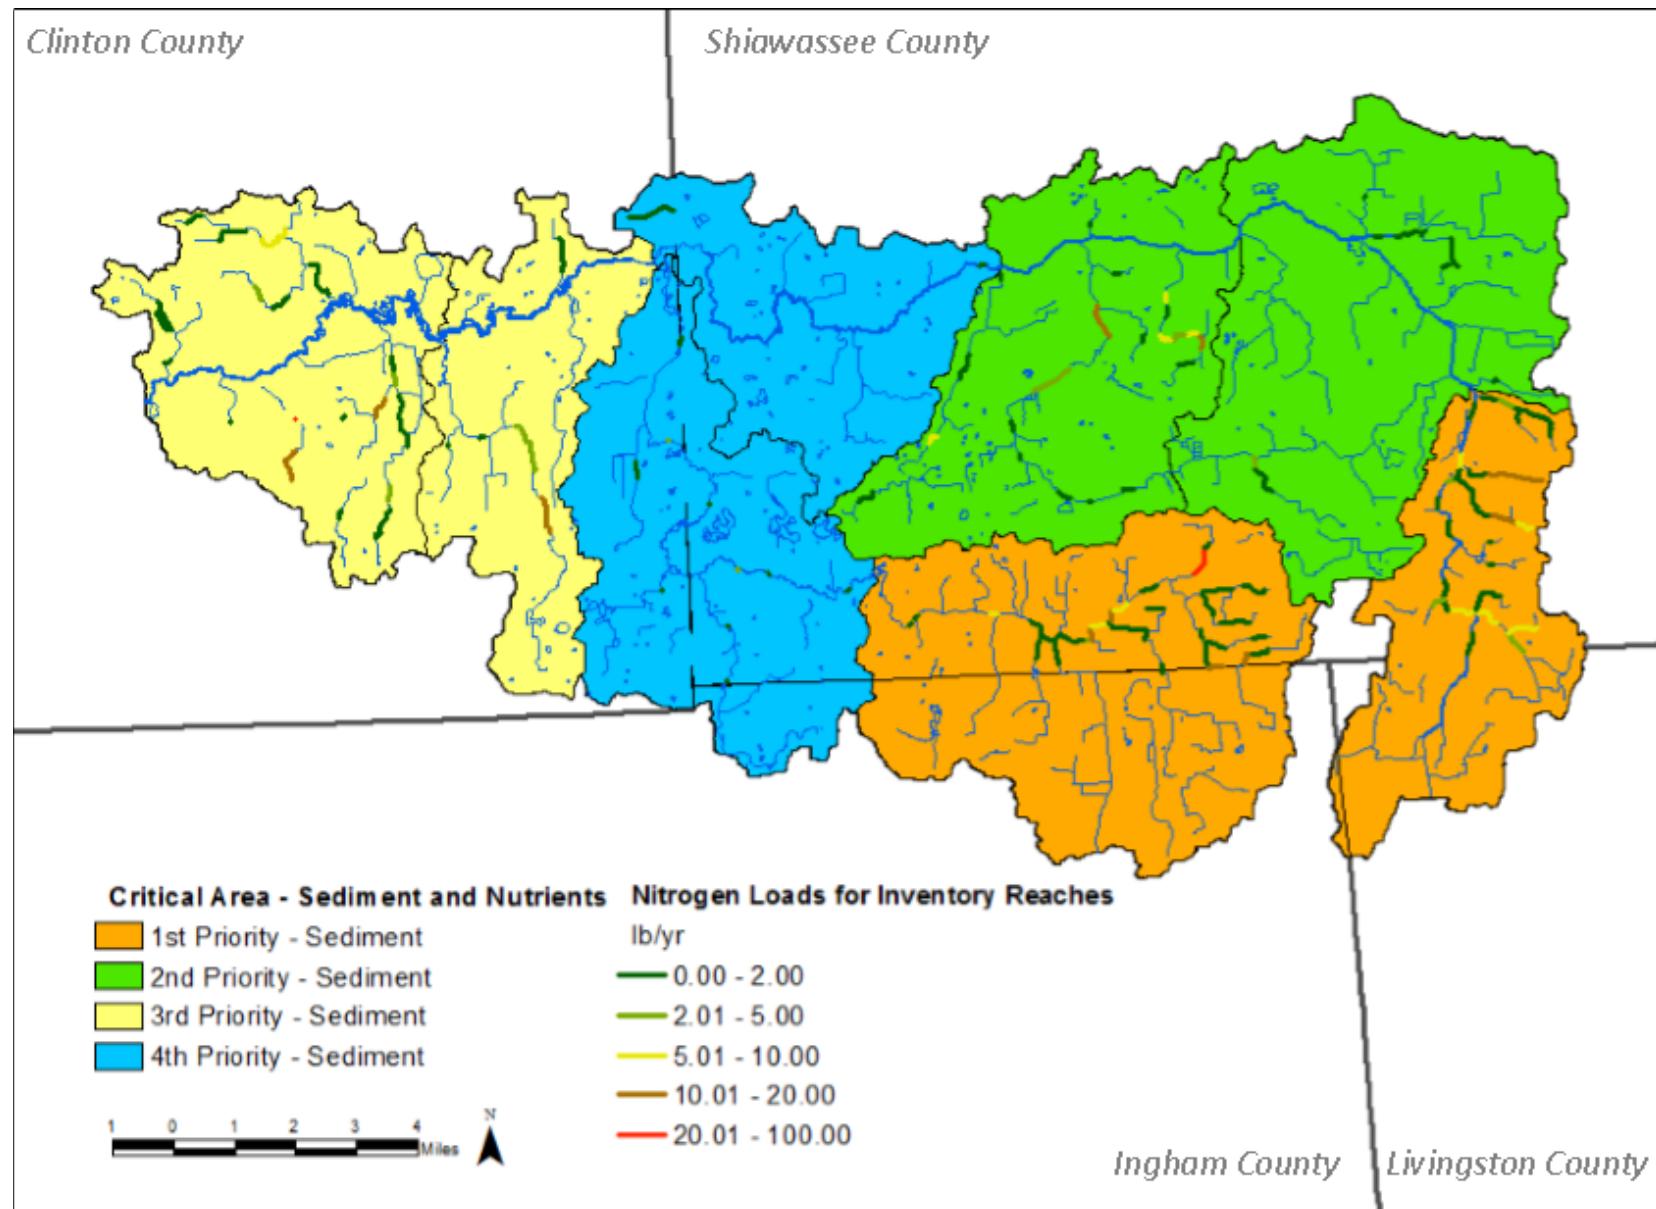
Figure 3.27 Nitrogen loads calculated from streambank and gully erosion noted during stream reconnaissance.

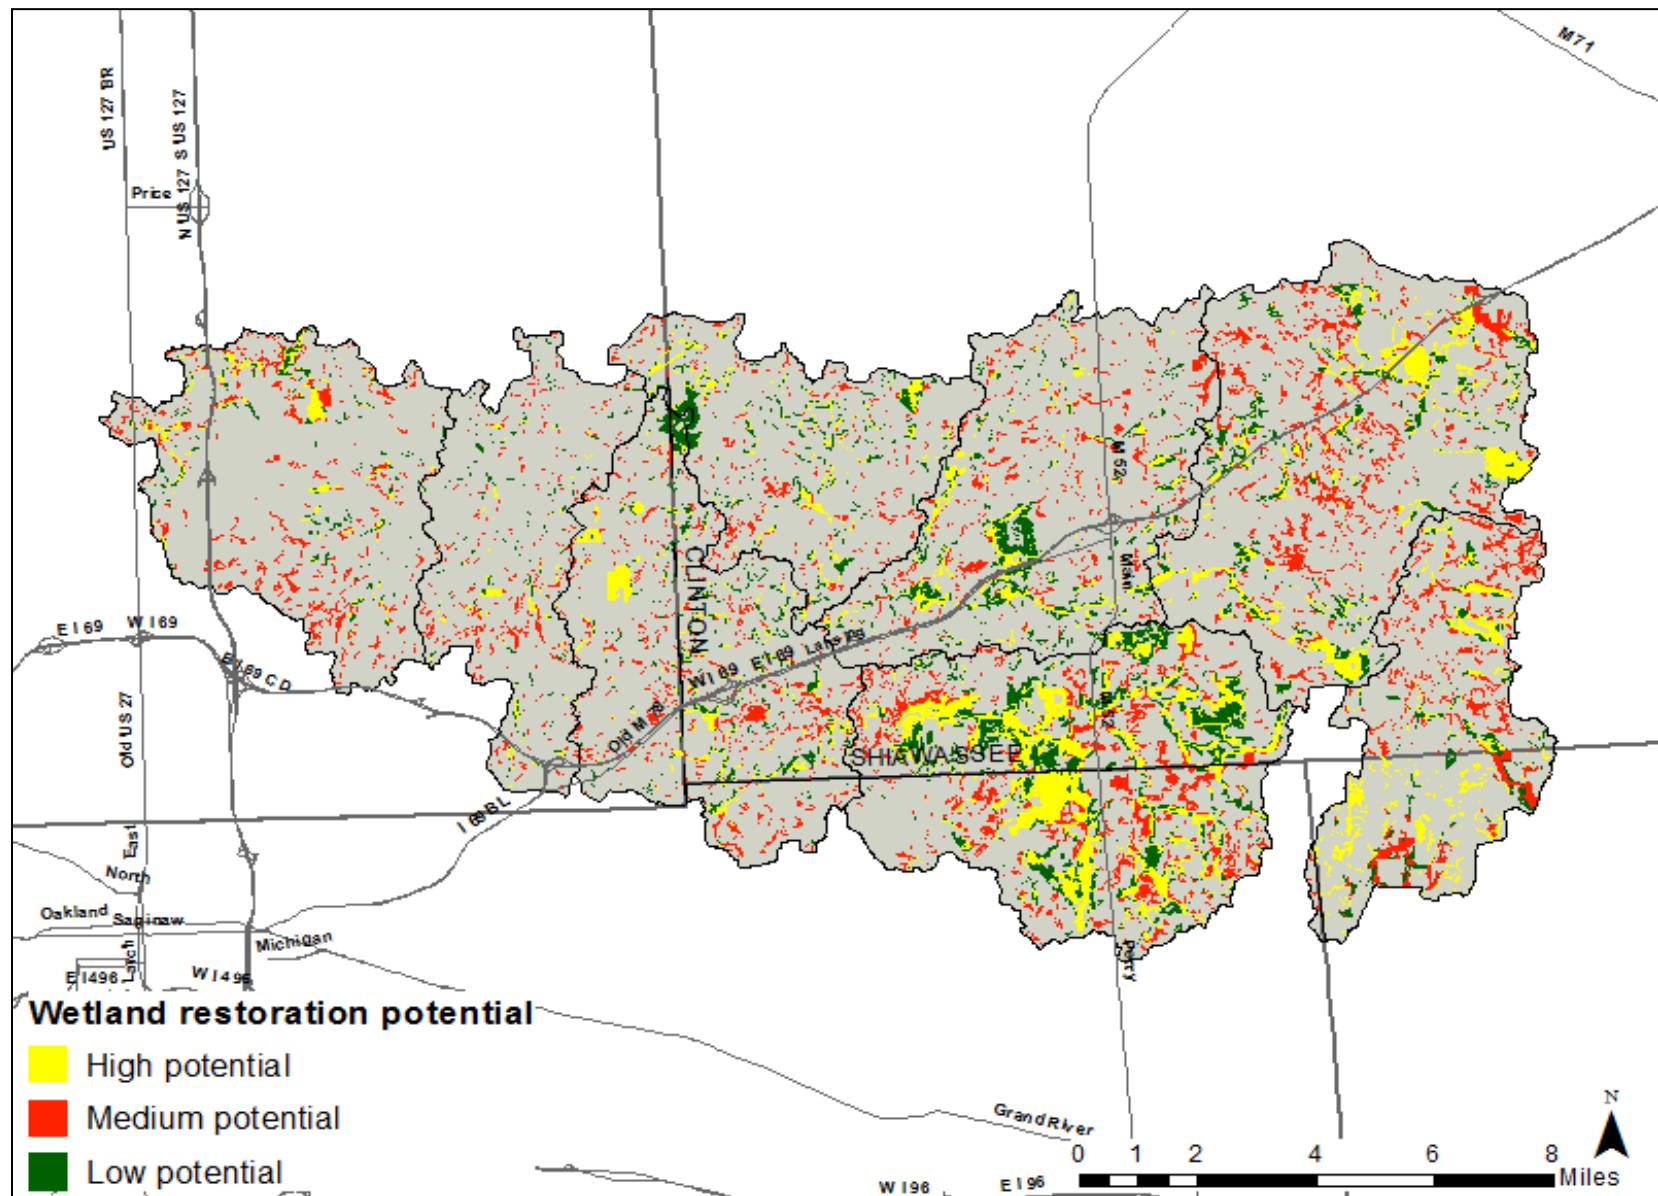
Figure 5.8 Potential wetland restoration areas in the Upper Looking Glass River Watershed (source MDEQ).

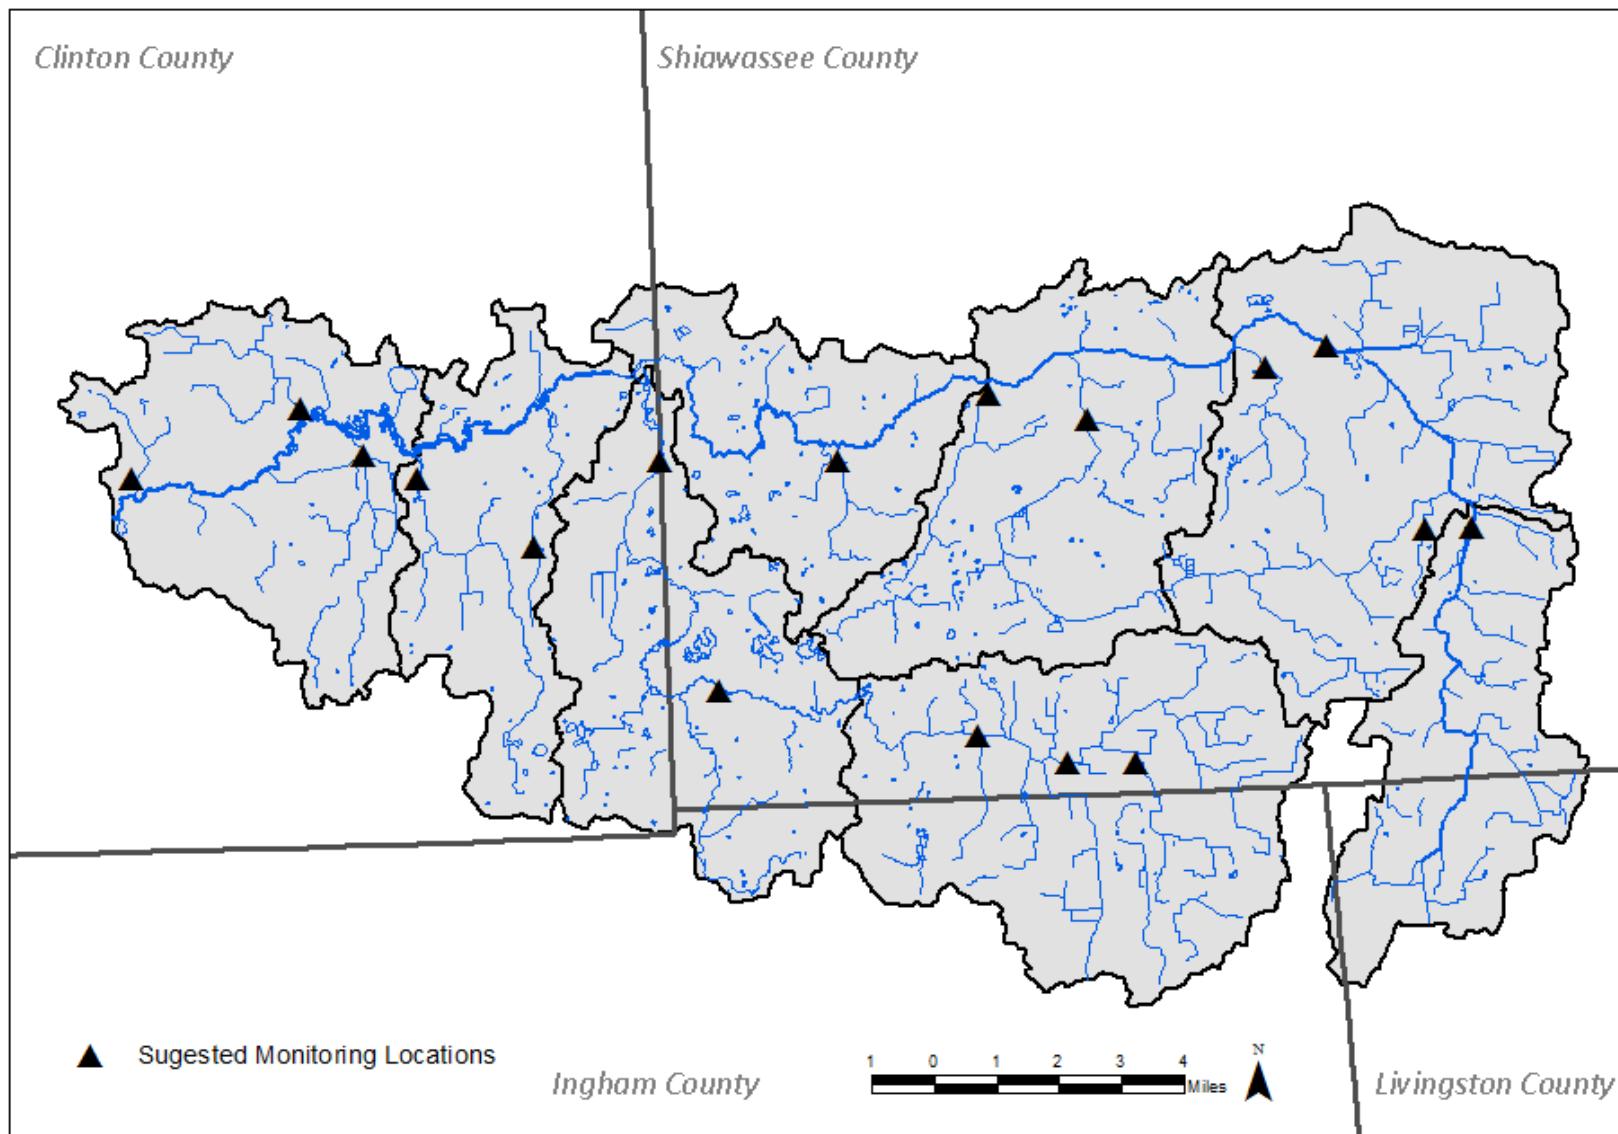
Figure 7.1 Recommended monitoring locations for the Upper Looking Glass River Watershed.
